April 8, 2022

DTC File No: J22-02110

**Re: Preliminary Sewage Dispersal System Assessment
Okanagan Gondola Development
Bailey Road, Vernon, BC**

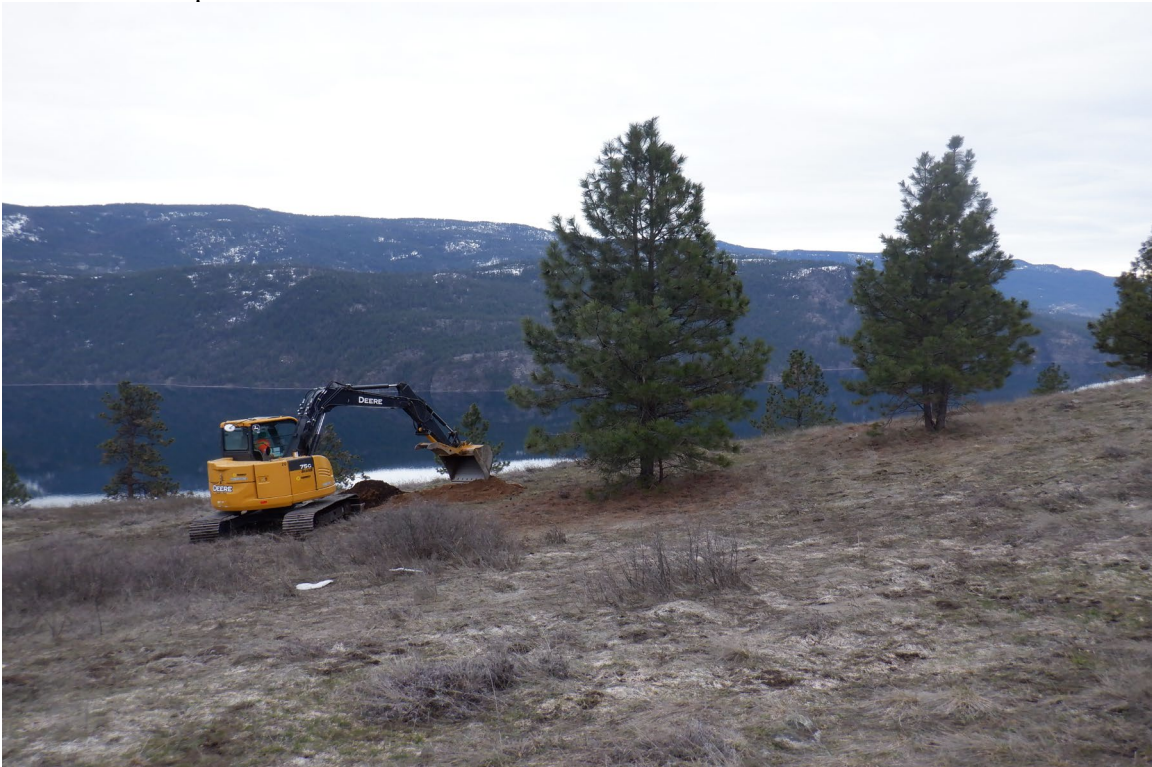
Photo #1 – testpit location bottom station.

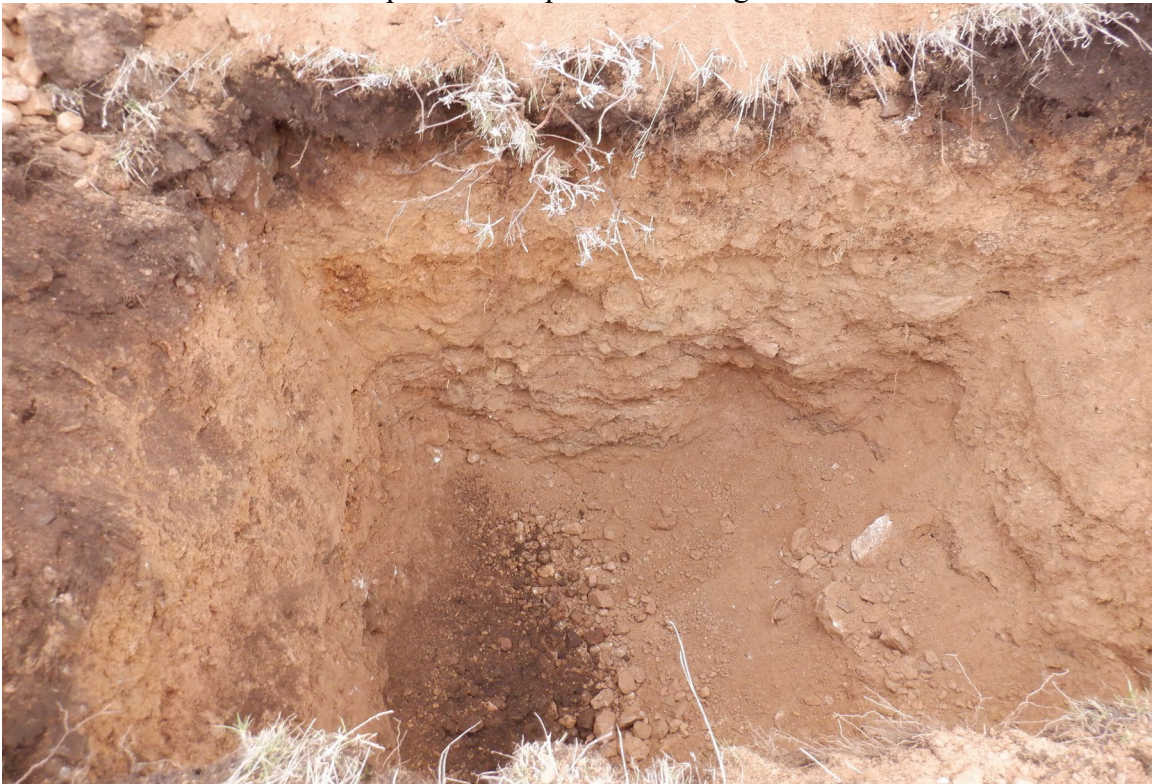
Photo #2 – bottom station testpit 2.0m deep with sand & gravel

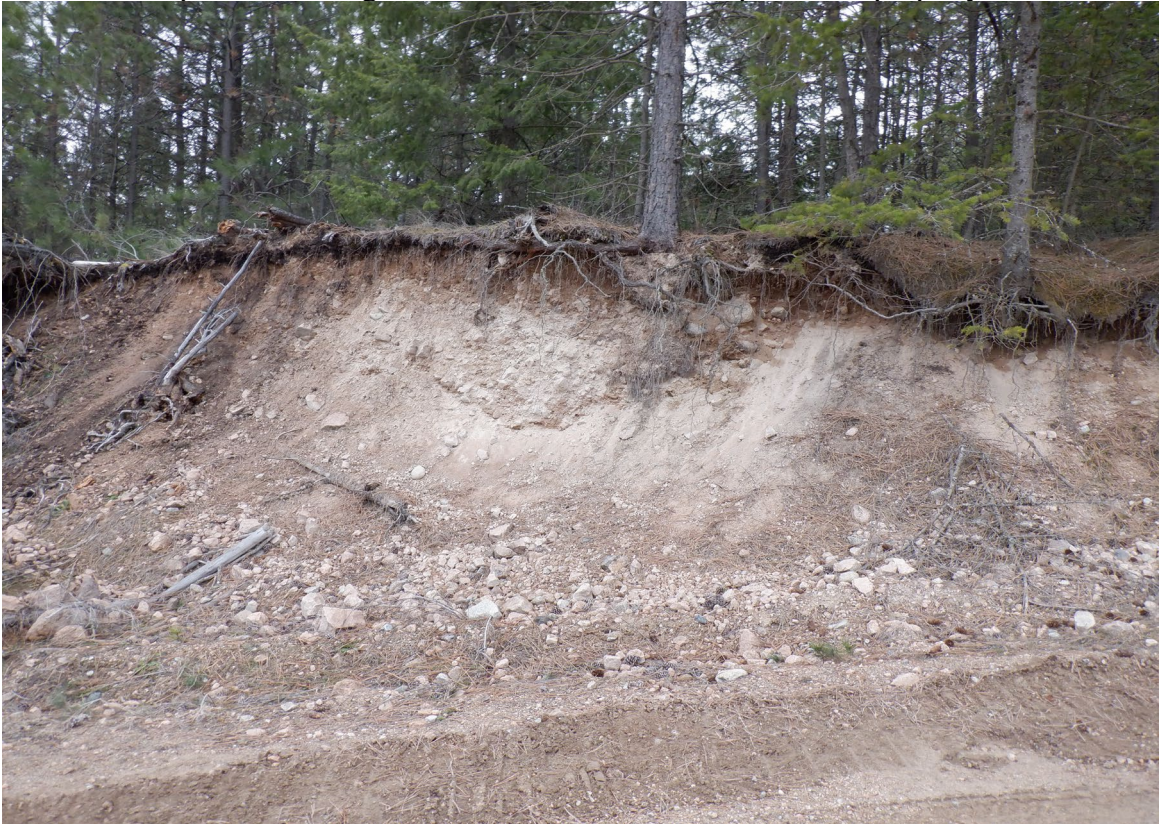
Photo #3 – exposed sand & gravel in road cut near lower portion of property.

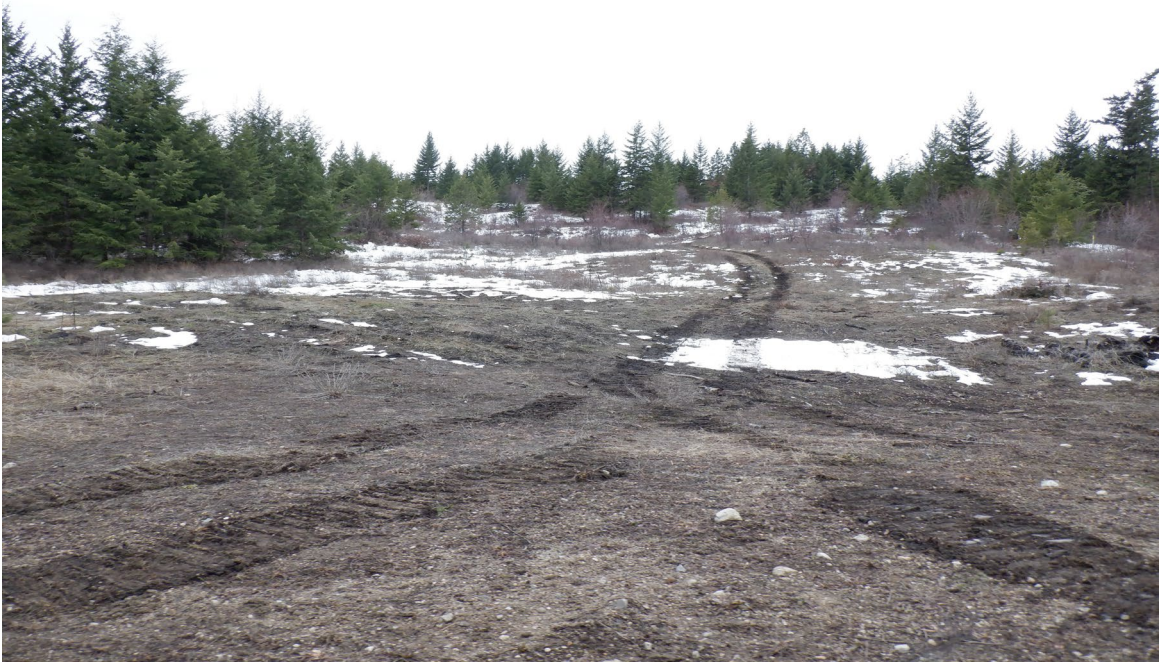
Photo #4 – possible dispersal field location for the mid station.

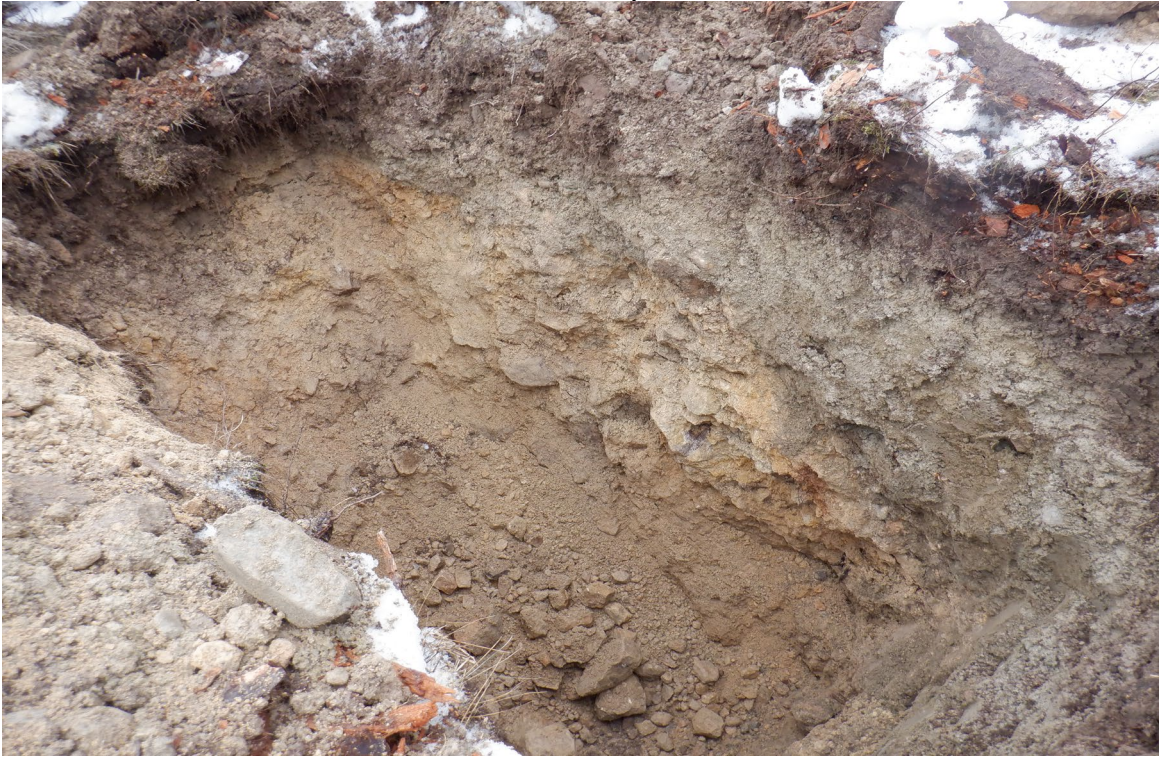
Photo #5 – testpit near the mid station, 2.8 m deep.

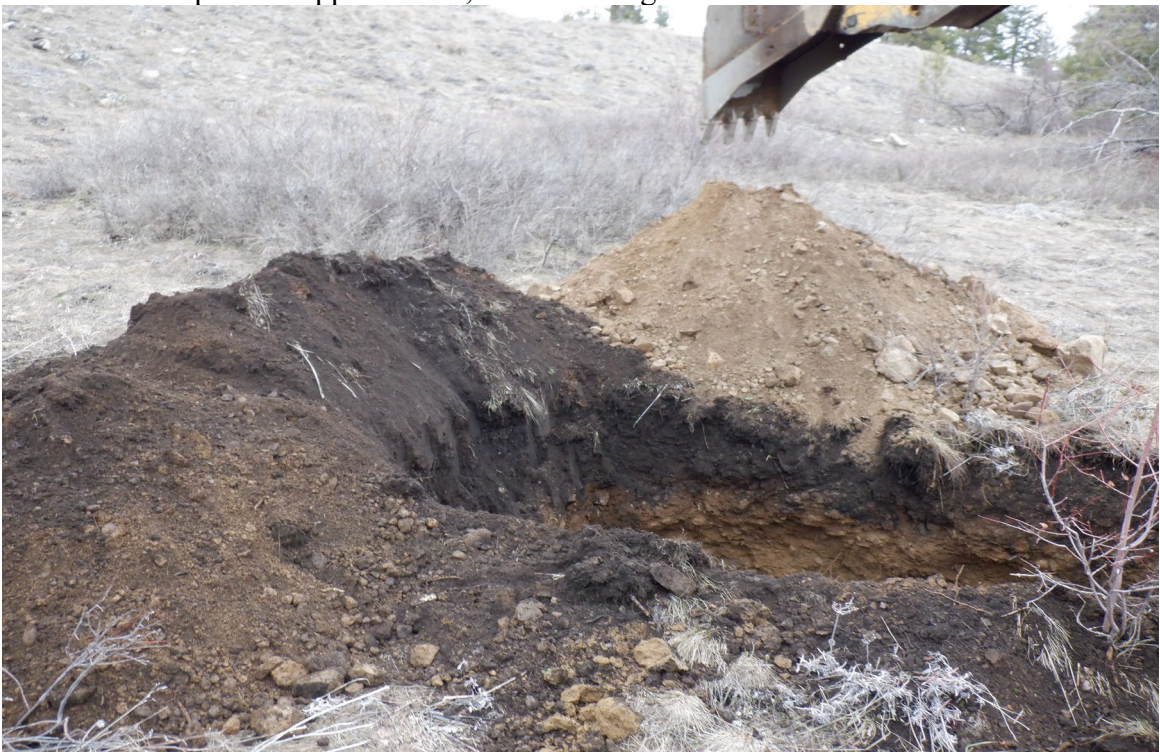
Photo #6 – testpit near upper station, 1.8m below grade.

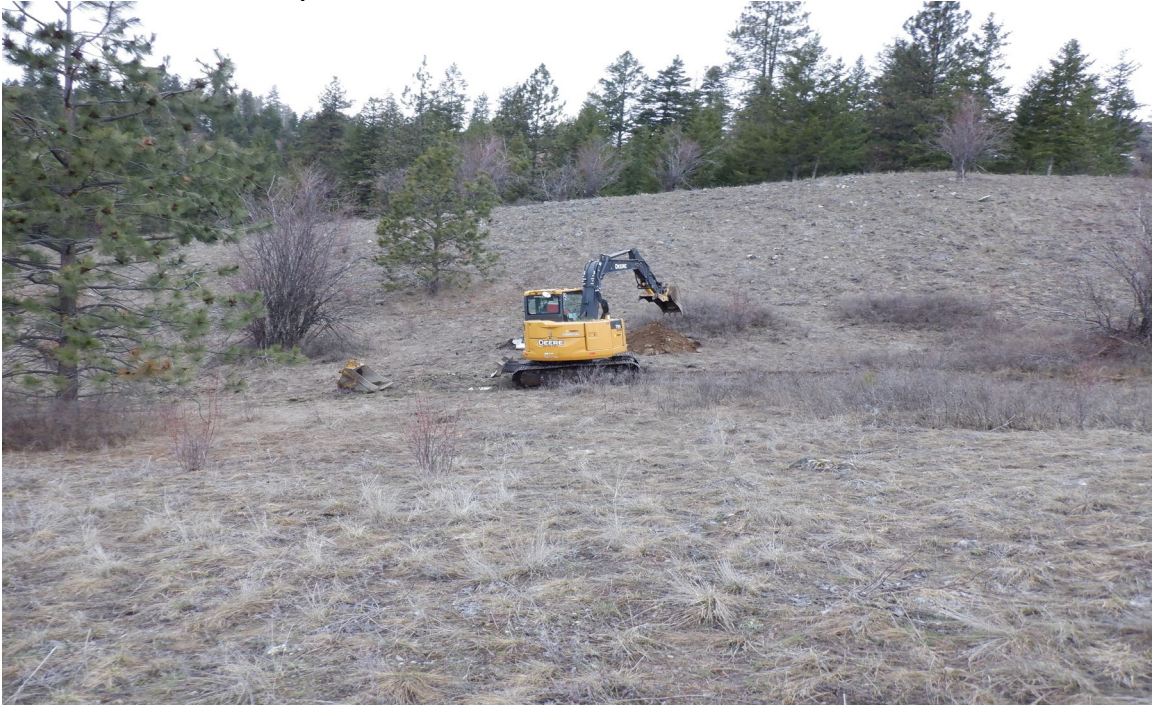
Photo #7 – view of testpit 14 location.
