Facility Assessment
for
Vernon Public Art Gallery
Regional District of North Okanagan
Vernon, BC

Final Report
May 2015

Report No. 126672a

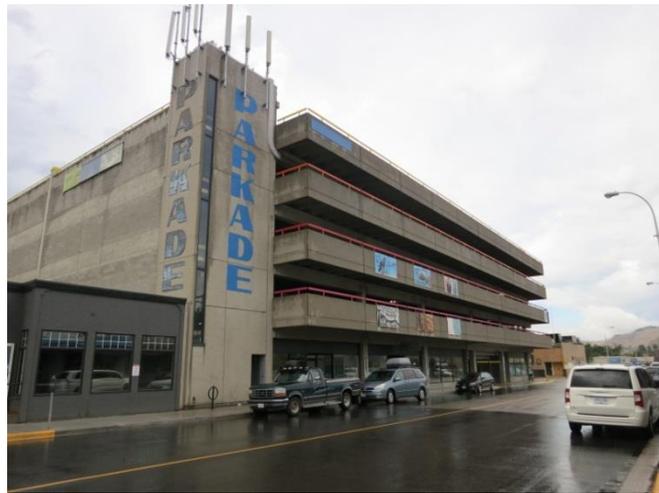
The Vernon Public Art Gallery – the oldest art gallery in the interior of British Columbia – is located in retail space on the ground floor of a parking garage (Figure 1) in downtown Vernon. The Gallery has been in this location since 1995, upgrading and expanding as adjacent retail space became available to create what is today a facility of just over 6,000 square feet with 4 exhibition galleries (Figure 2), a small retail shop and art rental area, several offices, a kitchen, washrooms, and two behind the scenes storage rooms.

Figure 1. VPAG's current location at 3228 31st Avenue.

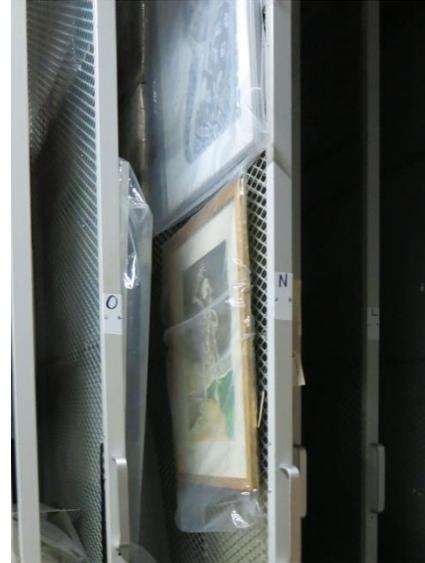
- frequent ongoing leaks seem inevitable due to poorly sealed concrete seams;
- many artworks were observed on the floor in storage – if only temporarily due to lack of space – where water tends to pool and the risk of water damage is highest;
- a single water detector may not detect flooding from the back of art storage or in any of the galleries.

Figure 5. Paintings covered in plastic to protect them from water leaks.

The plastic wrapping is a precaution against possible water leaks in the space and is generally not recommended for long-term art storage due to the danger of creating damp microclimates.

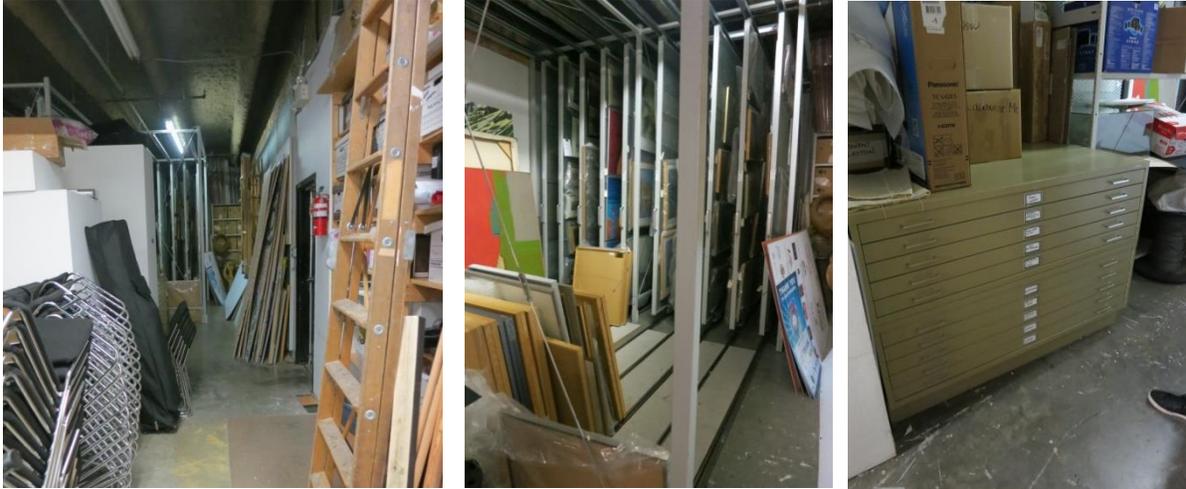
- no real separation of art storage from non-art storage;
- materials, tools and furniture stored along art movement path (Figure 6 left);
- art, frames and interpretive panels stored on floor in art rack area (Figure 6 centre);

Figure 6. Congestion in back storage room along path to loading bay door and art storage (left) and around art racks (centre) and on top of flat file cabinet.

- art racks are installed right up to the wall so that the wall side of the last rack has insufficient space for safe access (it is currently not used to store art);
- no dedicated space to set paintings on retrieval from or return to storage; and
- no space to set works of art on paper on retrieval from or return to flat file storage (Figure 6 right).

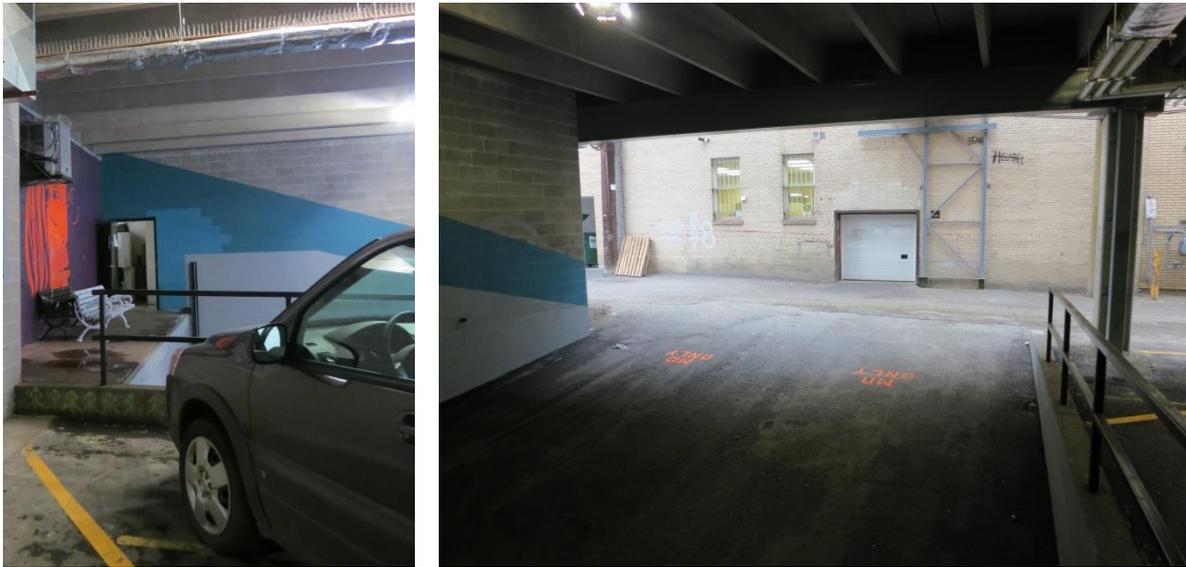
- turning radius from alley is too tight for typical art transport trucks;
- although protected from precipitation, crates cannot be brought directly from trucks into temperature controlled Gallery space;
- entrance to Gallery is through small single door; and
- route from loading bay to galleries is through crowded storage and requires several turns.

Due to the inadequacy of the loading bay, crates are usually brought in through the larger, double main doors at front which provide more direct access to the galleries but provide only partial protection from inclement weather. Even these doors limit considerably the size of crates and artworks that can be collected by or exhibited safely at VPAG.

Figure 7. VPAG loading bay with single door access (left) and small turning radius for trucks (right).

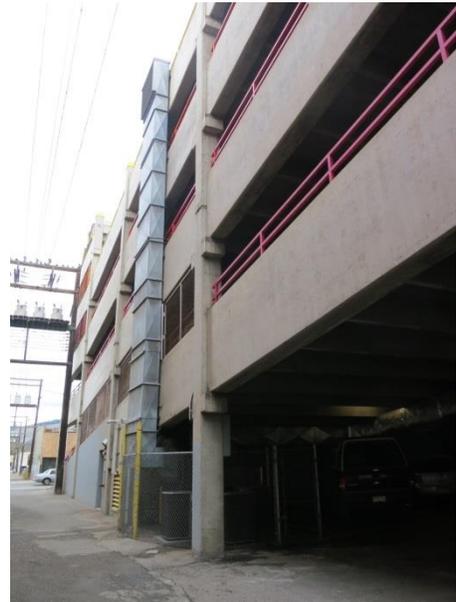
- the air intake was raised from the loading bay to the upper level of the parking garage (Figure 8) after smoke from a vehicle fire aspirated into Gallery;
- the system is equipped with medium efficiency Camfil Farr pleated filters that have a Minimum Efficiency Reporting Value (MERV) of 8.

Figure 8. HVAC air intake at the rear of the parking garage.

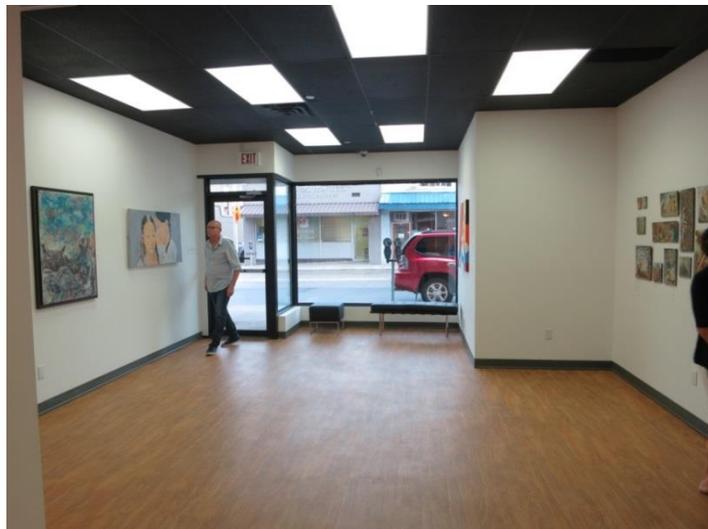
Large windows in the Community Gallery (Figure 8) and Up Front Gallery combined with fluorescent fixtures create lighting conditions that are not recommended for museum display of art:

Because art is displayed for only short period under these conditions, only the most sensitive, pristine colourants (ISO 1) displayed close to the windows will exhibit any noticeable fading within one exhibition (Table 2). Since fading is cumulative, each exhibition “uses up” more colourant than would identical display period at recommended museum settings (Table 2). For example, sensitive works displayed at 450 lux with high UV will fade:

- about 4-9 times faster than if displayed in UV-filtered light at 150 lux, and
- 12-26 times faster than if displayed at 50 lux.

Figure 8. Windows and fluorescent lighting in the Community Gallery.
