## Sediment Impact to GVW Kalamalka Lake Intake Study, 2018

Prepared for  
Regional District of North Okanagan

Report prepared by: Larratt Aquatic Consulting Ltd.

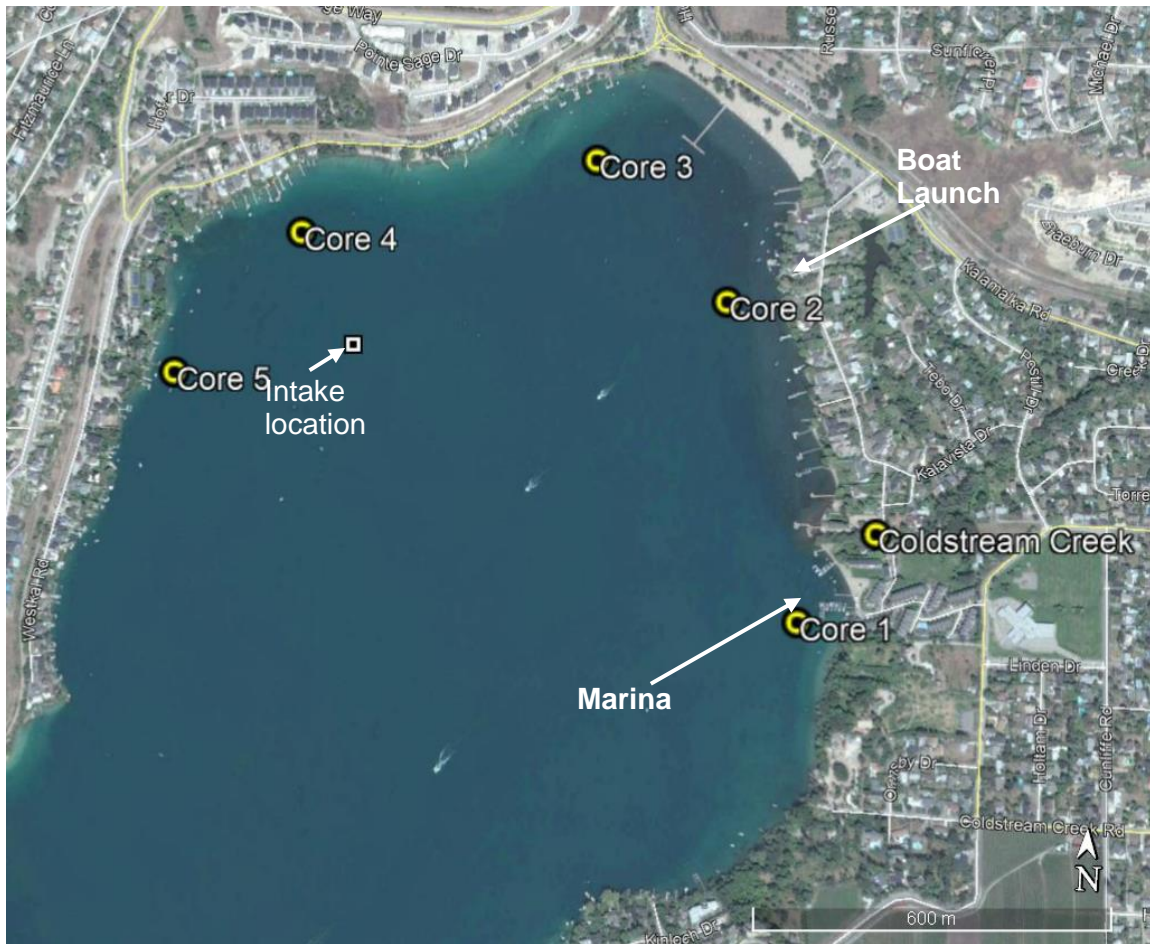
Figure 3-1: Map of Sediment core locations in North Arm of Kalamalka Lake

Sediment cores were collected at five lake sites and one site within Coldstream Creek, and were distributed along the shoreline of the North Arm focusing on sites offshore from areas of high potential impact (Figure 3-1). None of the sediment core sites were directly adjacent to shoreline contamination sources; rather, they were located in areas of high boating activity within 40 - 125 m of the shoreline and should therefore reflect sediment re-distribution by turbulence.

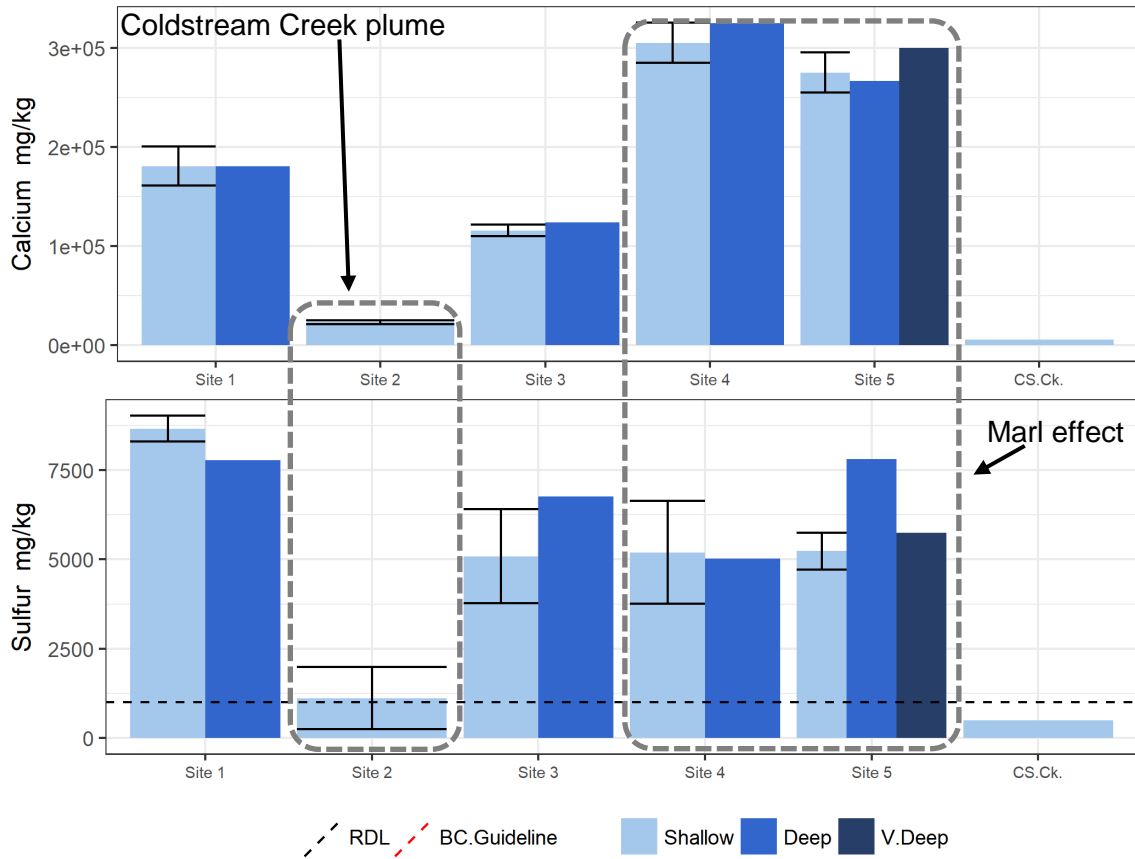
**Figure 3-2: Calcium, and sulfur concentrations in Kalamalka Lake sediment cores**  
Note: BC MoE sediment guidelines are off the scale, i.e. values were far below the guideline

This 2018 study shows interesting patterns of metal accumulation within the past few decades. There was a clear difference in sediment marl concentrations from samples collected close to the mouth of Coldstream Creek and those collected a distance from it. Lake sediments were very high in the marl constituents calcium and sulfur, while sediments within Coldstream Creek and its plume paths were low in these parameters

(Figure 3-2). As a result, Core Sites 1, 2, and 3 show varying degrees of creek sediment deposition, while Core Sites 4 and 5 are more typical of shallow Kalamalka Lake marl sediments.

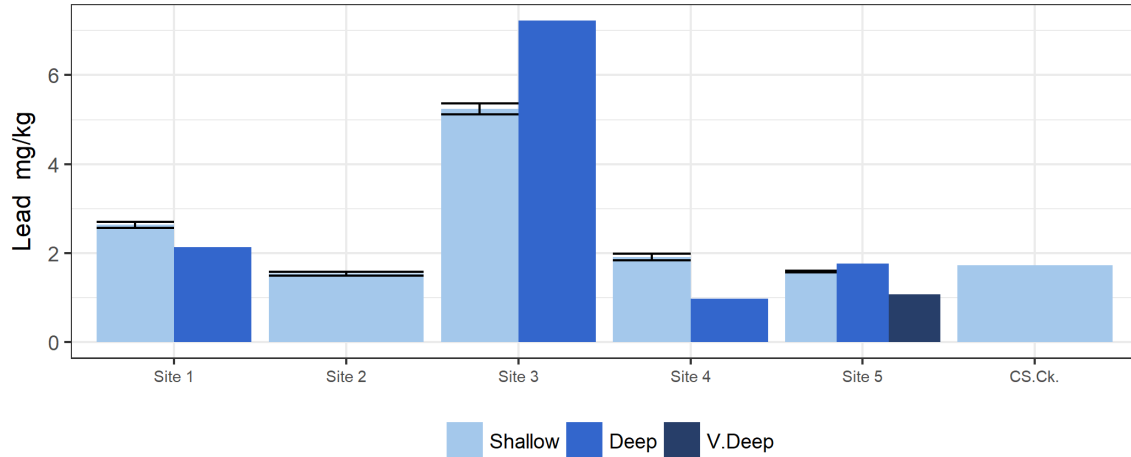
**Figure 3-4: Lead concentrations in Kalamalka Lake core sediment samples**

Note: BC MoE sediment guideline is above the scale on this graph, i.e. values were far below the guideline

Lead was elevated at Core Site 3 in both shallow and deep sediments and was similar at the other five sites (Figure 3-4). Lead did not exceed the BC MoE sediment guideline (35 mg/kg) at any site. Lead is a legacy pollutant that was restricted or banned in the 1970s. Downward trends of these legacy pollutants have been noted since they were banned in most jurisdictions; however, residual lead sources remain in the urban environment.

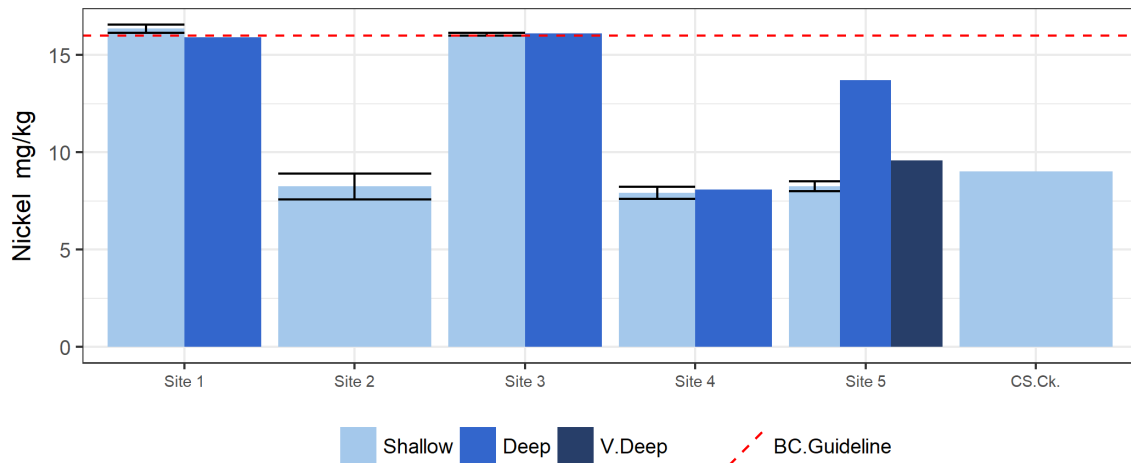
**Figure 3-5: Nickel concentrations in Kalamalka Lake sediments**

In the sediment core samples, only nickel exceeded the BC MoE sediment guidelines (Figure 3-5). The results exceeded the guideline by 1-3%; however, nickel is both persistent and toxic. In flowing water, nickel is transported mainly as a precipitated coating on particles and in association with organic matter (Cempel and Nickel 2006). This could explain why the exceedances occurred at Cores sites 1 and 3 that flank the shoreline Coldstream Creek plume path, where fine sediments and organics would deposit. Additionally, Core Sites 1 and 3 could receive Ni from a marina and stormwater outfalls, respectively, that are both well-known Ni sources (NCDEM, 1991).

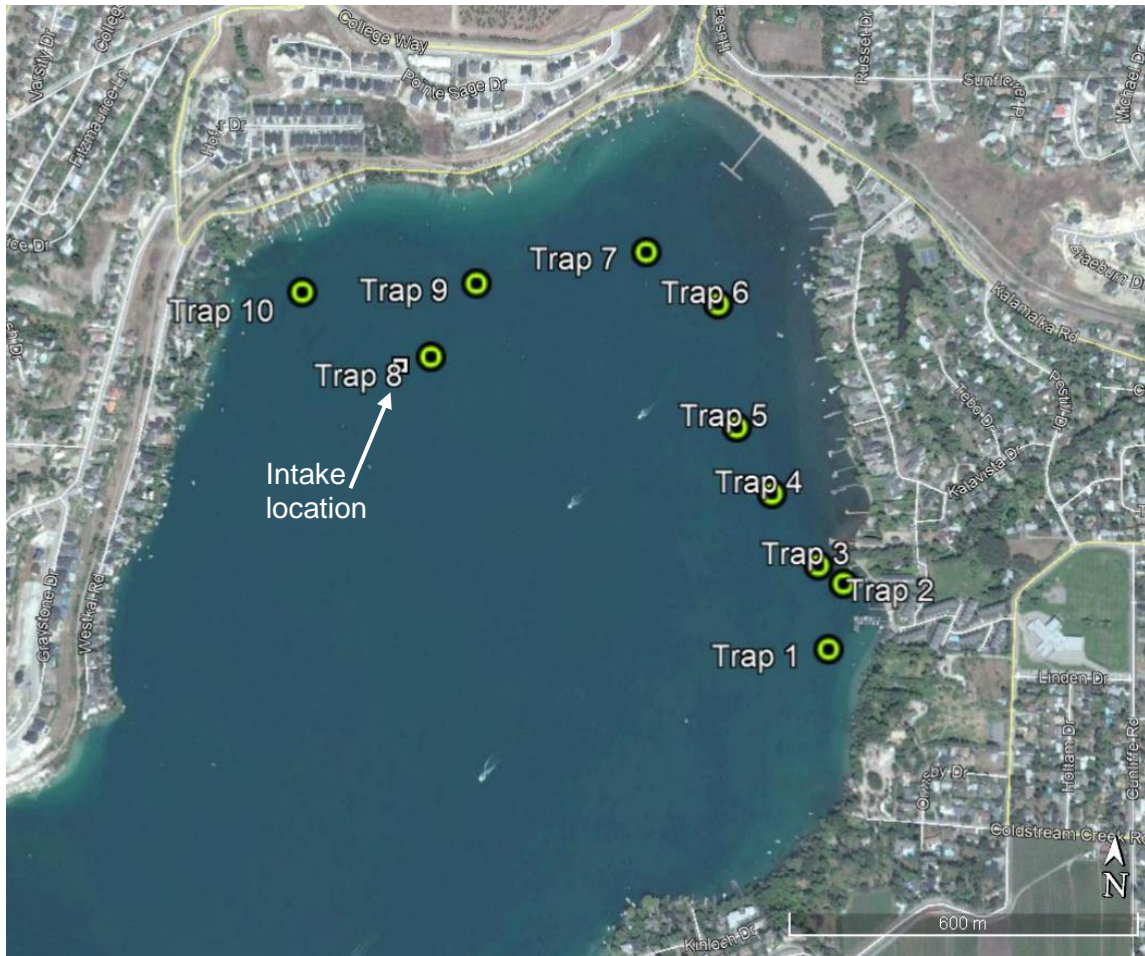
Figure 3-8: Sediment trap locations within North Arm, Kalamalka Lake

Sediment caught in the traps represents newly deposited sediments or redeposition of disturbed substrates in summer 2018 (Figure 3-8). The purpose of these traps was to measure the sedimentation rate within the North Arm during the main boating season,

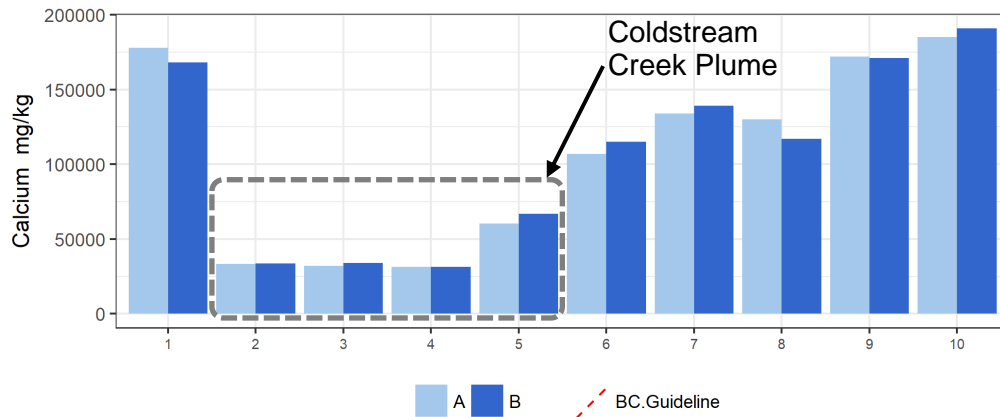
**Figure 3-10: Calcium concentration in sediment collected in sediment traps in North Arm Kalamalka Lake**

The sediment trap material was analyzed for metals to give an indication of metals accumulating within the North Arm during 2018. The metal concentrations were similar to the sediment cores, but the effect of Coldstream Creek was more distinct. Marl-associated metals such as calcium were lowest around the mouth of Coldstream Creek (Figure 3-10).

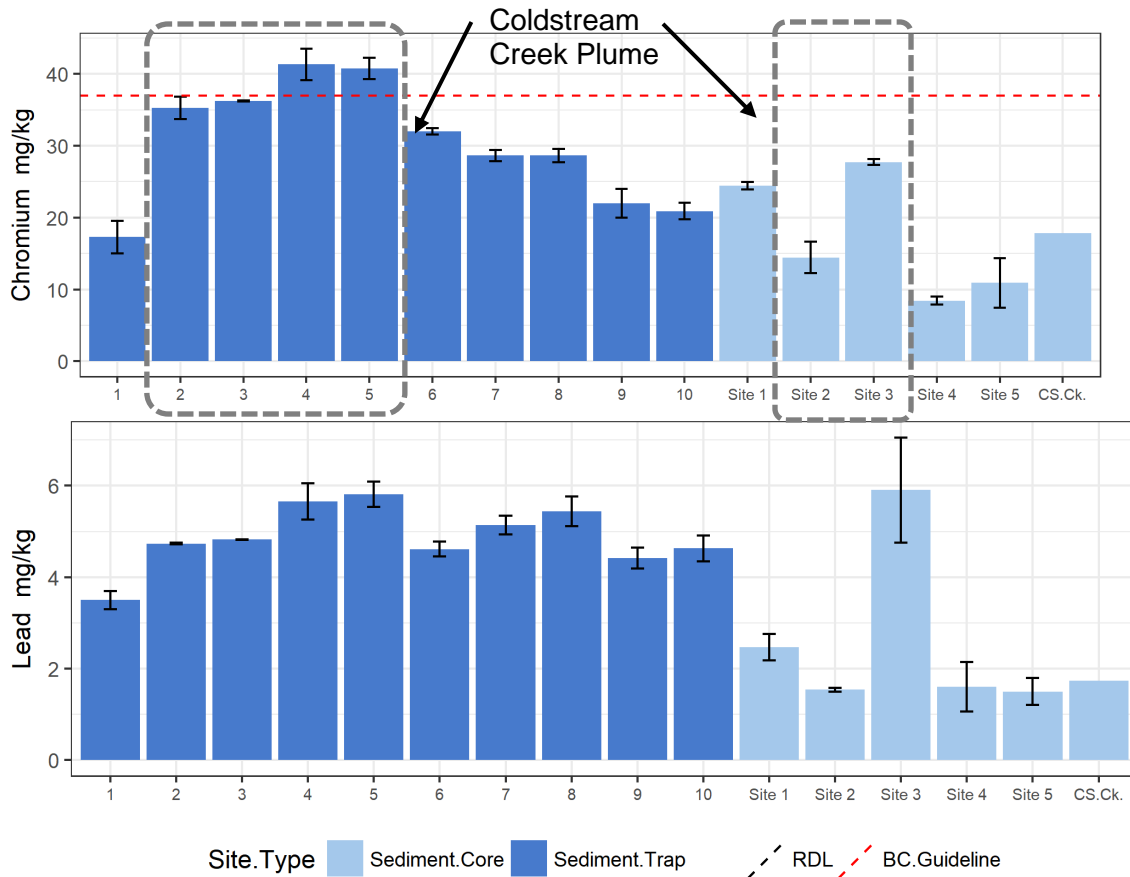
**Figure 3-11: Comparison of chromium and lead concentrations in the sediment cores (historical accumulation) and sediment traps (2018 accumulation)**

Note: Reportable detection limit (RDL) not displayed on these graphs because all samples had detectable values. Please refer to Methods for metal RDL's

The distribution of several metals followed a similar pattern indicating Coldstream Creek was the likely source (Figure 3-11; Figure 3-12; Figure 4-5). These metals included: aluminum, antimony, arsenic, beryllium, cadmium, chromium, cobalt, copper, iron, lead, lithium, nickel, potassium, silver, thallium, thorium, titanium, vanadium, zinc, and zirconium. There was a clear increase in these metals at Trap Sites 2 through 6 that have been identified as being within the Coldstream Creek plume in other research (Larratt and Self 2017). Chromium, copper, iron, and nickel exceeded their BC MoE sediment guidelines at several sites with Sites 4 and 5 having the highest concentrations. There were more exceedances in the sediment trap data than the sediment cores, which means that heavy metal loading into Kalamalka Lake sediments is an ongoing concern.

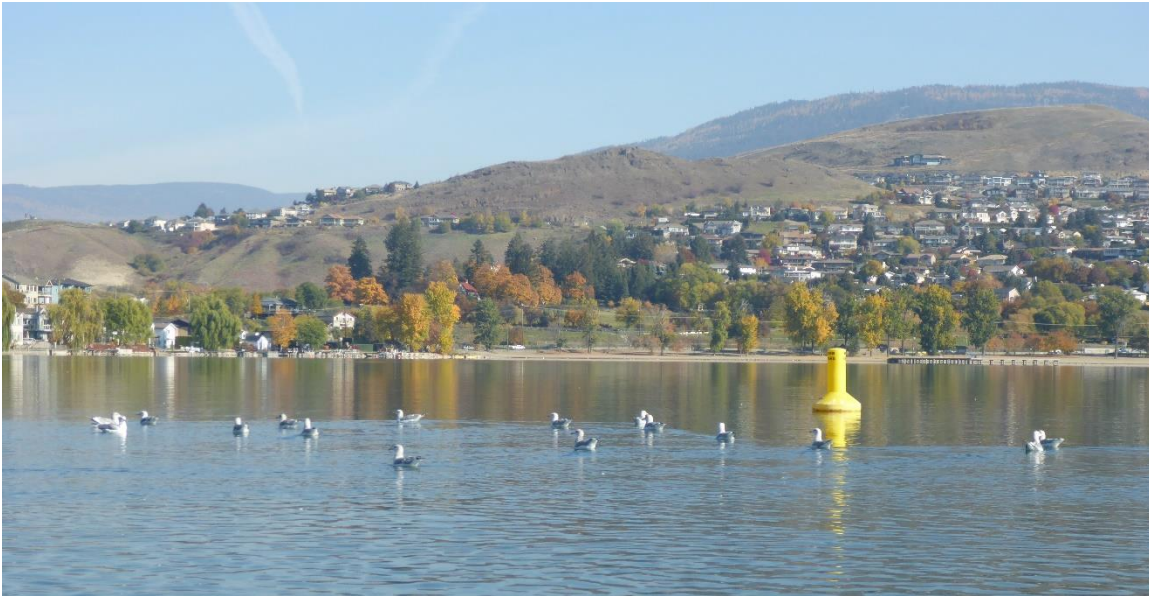
**Figure 3-14: Seagulls resting near the marker buoy for the RDNO Kalamalka Lake drinking water intake**

Fecal bacteria concentrations were measured in the sediment captured in the sediment traps. Counts were elevated at Trap Site 7 and 8. High *E. coli* counts in the sample from Site 8 – the closest to the RDNO drinking water intake – unfortunately indicate ongoing bacterial accumulation near the intake. A marker buoy installed near the intake in 2016 has become a popular resting spot for birds (Figure 3-14). It is possible that feces from these birds are the main source of the elevated *E. coli* counts at Trap Site 8. Alternately, sediment disturbance from shallower contaminated sediments can transfer bacteria to deeper locations. In any case, the elevated counts near the RDNO intake is concerning. For Trap Site 7, the source of fecal bacteria is likely a nearby cluster of stormwater outfalls (Section 3.1.2). Sediment trap Site 10 was also in the deep intake area and again, showed higher bacteria counts than the other North Arm sites over summer 2018. Finally, Trap Site 3 is also adjacent to stormwater and Coldstream Creek plume, and it had more fecal bacteria than background sites. High concentrations of fecal coliforms and *E. coli* were detected in North Arm stormwater in other work (Summit 2012, Kerr Wood Liedel 2016). These counts are important because the sediments can act as a bacterial reservoir and return viable bacteria to the water column during turbulence (Ishii et al, 2007; Laliberte and Grimes 1982).
