REGIONAL DISTRICT OF NORTH OKANAGAN

BYLAW No. 2940

A bylaw to amend the Electoral Area “F” Official Community Plan Bylaw No. 2702, 2016 and amendments thereto.

1. This Bylaw may be cited as “***Electoral Area “F” Official Community Plan Amendment Bylaw No. 2940, 2022***”.

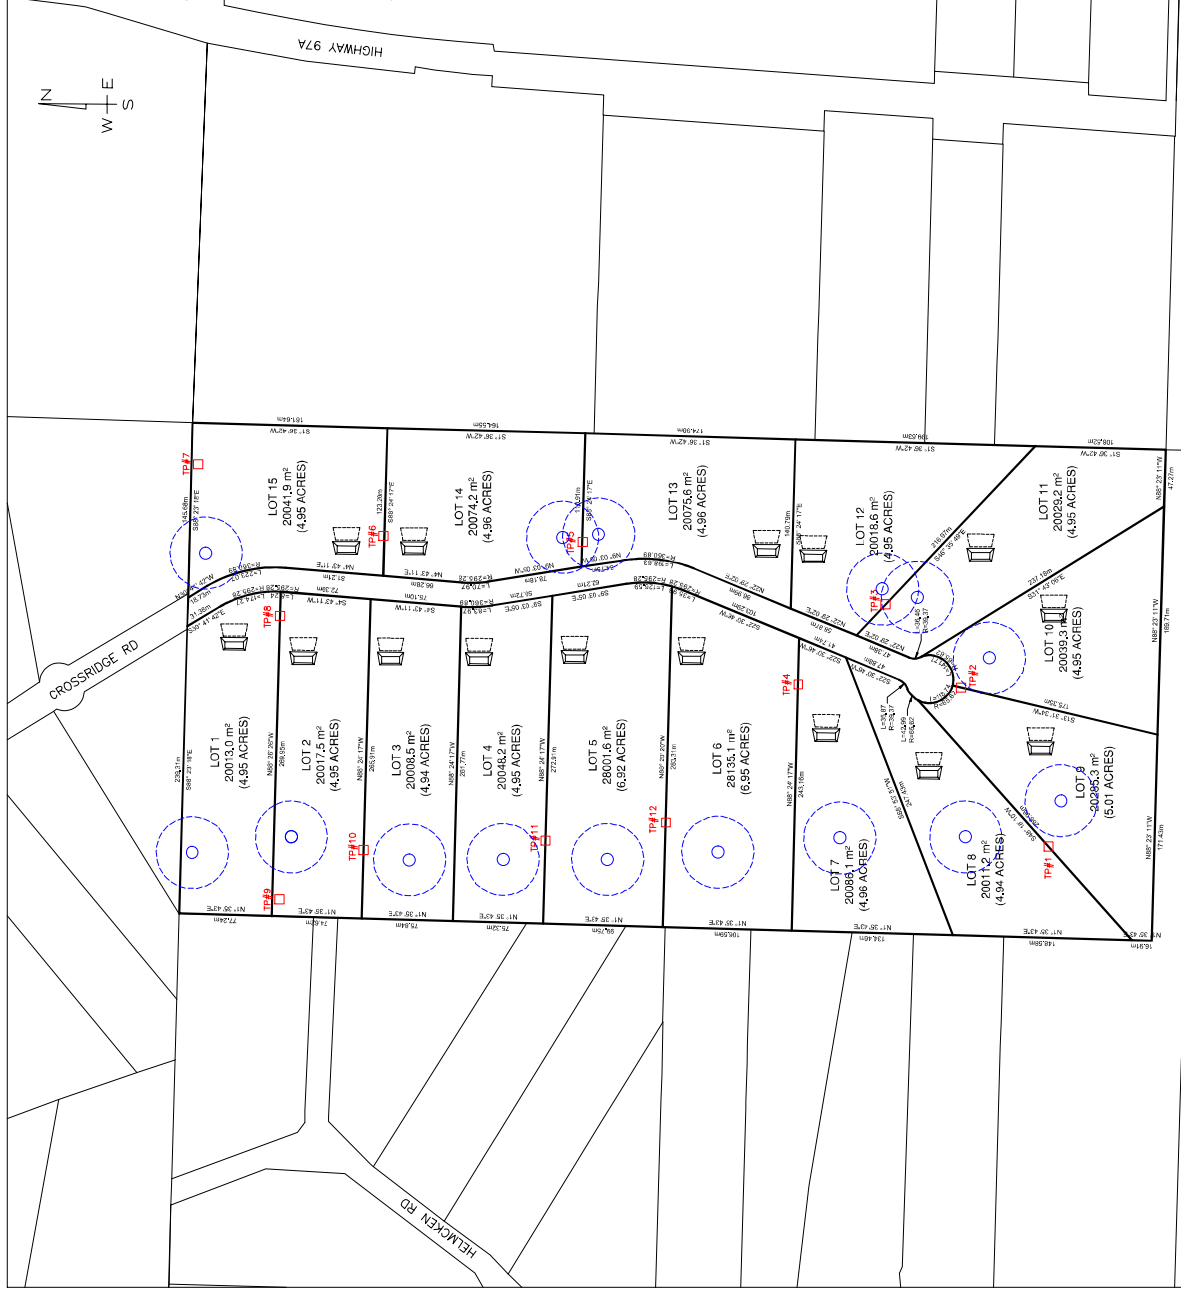
30m WELL SETBACK

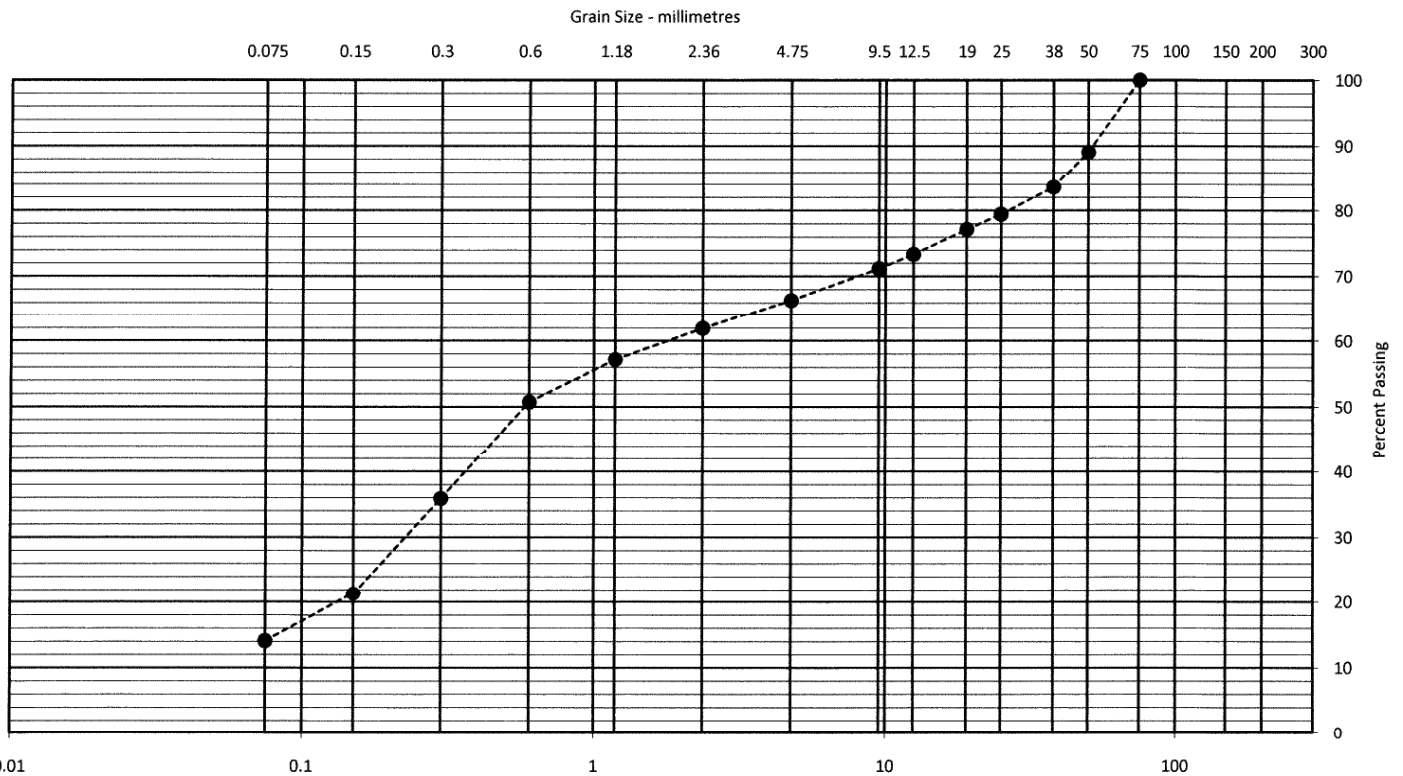
Sample: Test Pit 3, Sample 1, Depth 0.6 m

Wash Analysis			
Sieve (mm)	% Passing	Sieve (mm)	% Passing
300		12.5	73.4
200		9.5	71.2
150		4.75	66.4
100		2.36	61.9
75	100	1.18	57.2
50	89.1	0.6	50.7
38	83.6	0.3	35.9
25	79.5	0.15	21.4
19	77.1	0.075	14.0

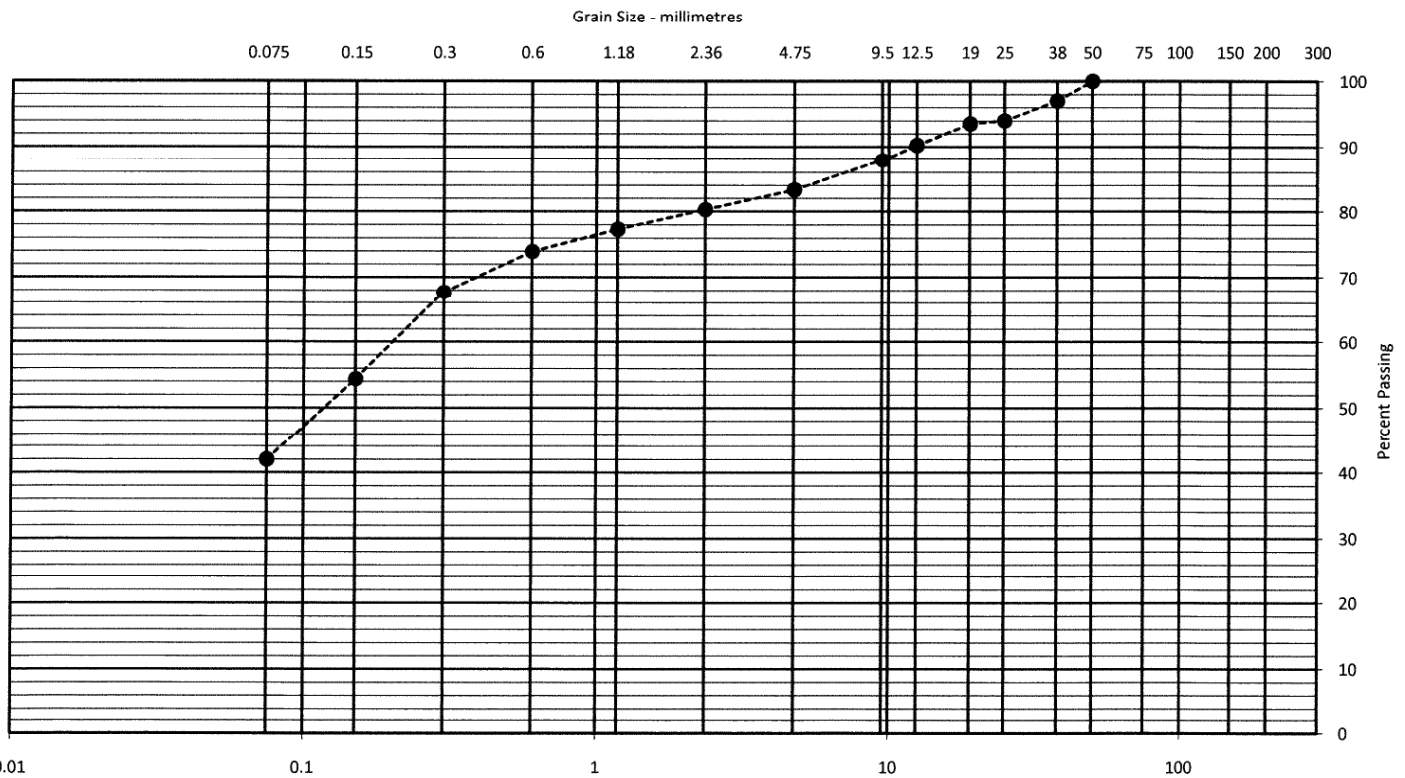
Sample: Test Pit 6, Sample 2, Depth 2.5 m

Wash Analysis			
Sieve (mm)	% Passing	Sieve (mm)	% Passing
300		12.5	90.3
200		9.5	87.9
150		4.75	83.3
100		2.36	80.3
75		1.18	77.3
50	100	0.6	74.0
38	97.0	0.3	67.7
25	94.0	0.15	54.4
19	93.5	0.075	42.0

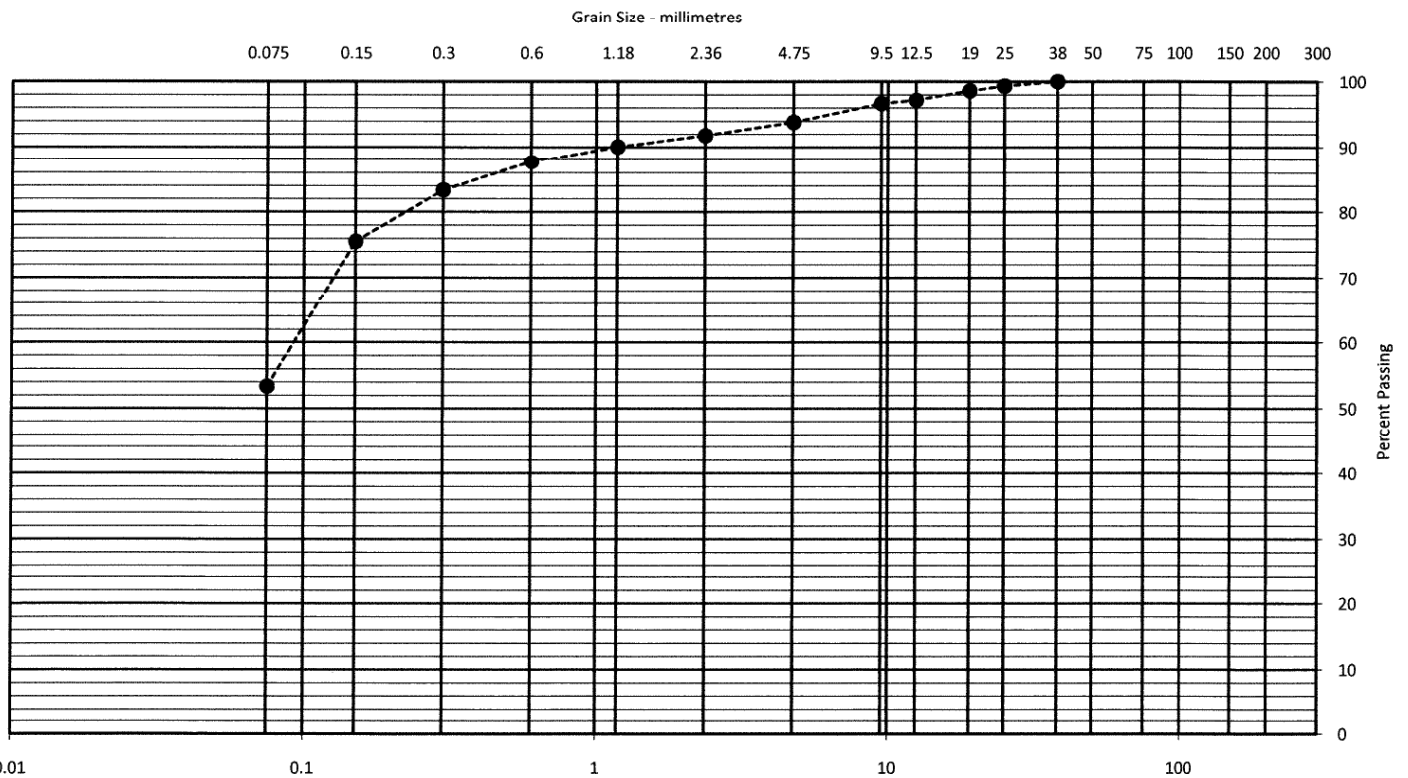
Sample: Test Pit 7, Sample 1, Depth 1.2 m

Wash Analysis			
Sieve (mm)	% Passing	Sieve (mm)	% Passing
300		12.5	97.2
200		9.5	96.7
150		4.75	93.8
100		2.36	91.8
75		1.18	90.1
50		0.6	87.7
38	100	0.3	83.3
25	99.3	0.15	75.5
19	98.6	0.075	53.4

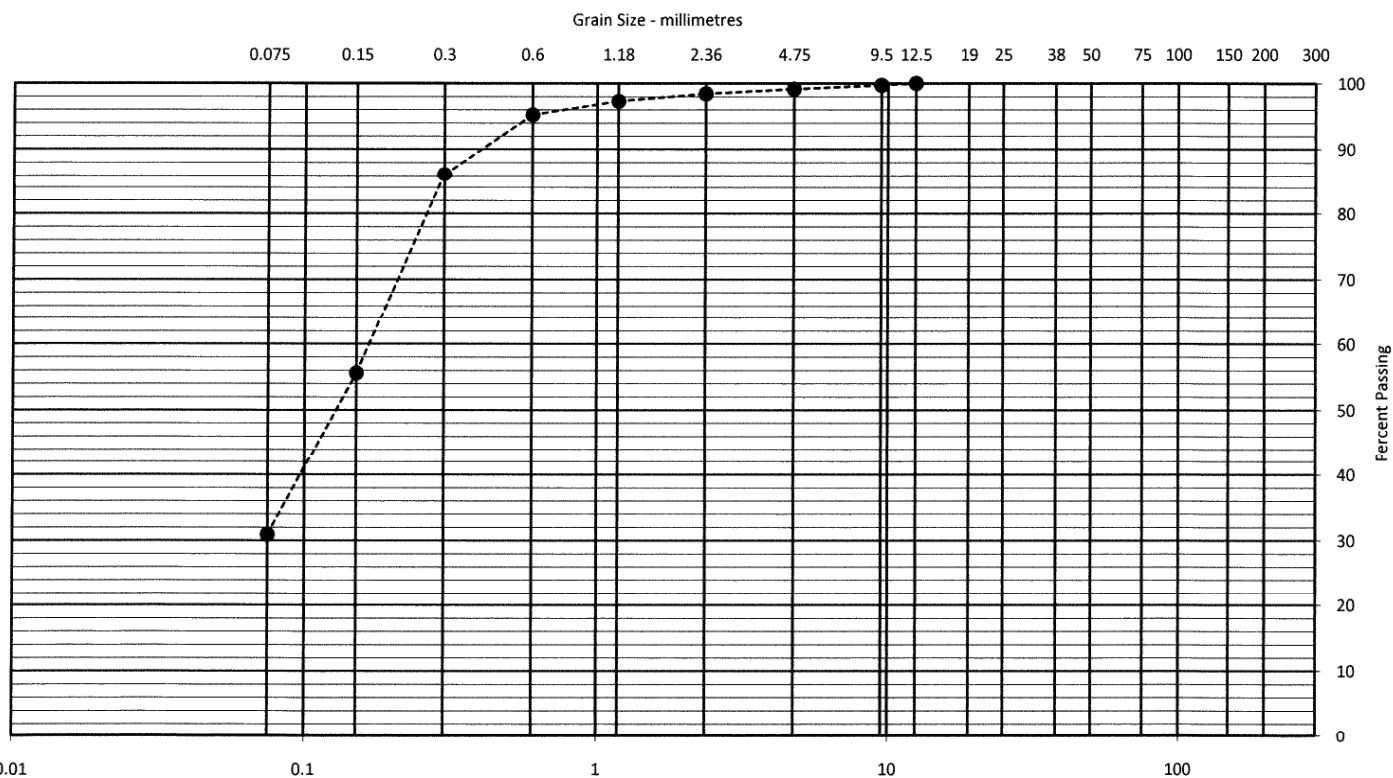
Sample: Test Pit 9, Sample 1, Depth 1.8 m

Wash Analysis			
Sieve (mm)	% Passing	Sieve (mm)	% Passing
300		12.5	100
200		9.5	99.7
150		4.75	99.1
100		2.36	98.4
75		1.18	97.3
50		0.6	95.2
38		0.3	86.1
25		0.15	55.6
19		0.075	30.9

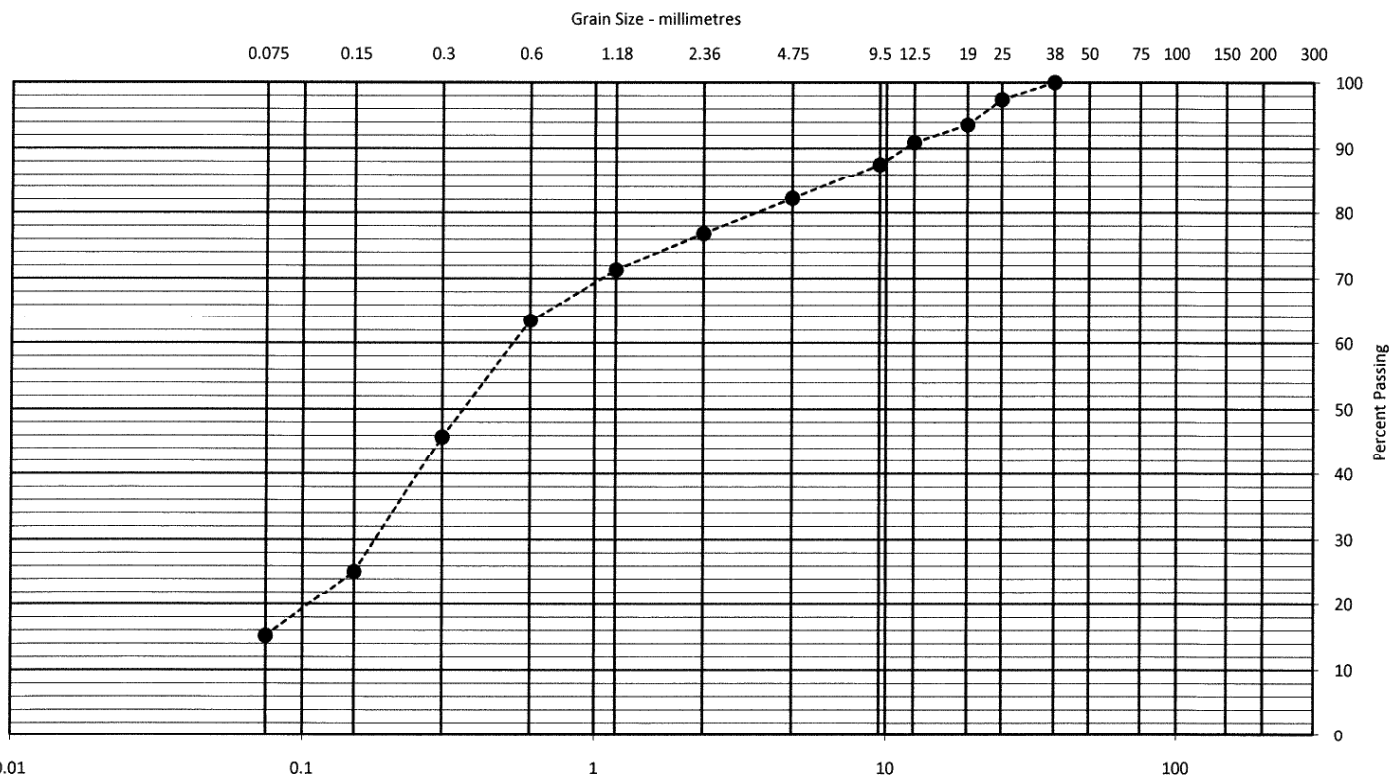
Sample: Test Pit 11, Sample 1, Depth 1.2 m

Wash Analysis			
Sieve (mm)	% Passing	Sieve (mm)	% Passing
300		12.5	90.9
200		9.5	87.5
150		4.75	82.2
100		2.36	76.9
75		1.18	71.3
50		0.6	63.5
38	100	0.3	45.7
25	97.4	0.15	25.1
19	93.6	0.075	15.2

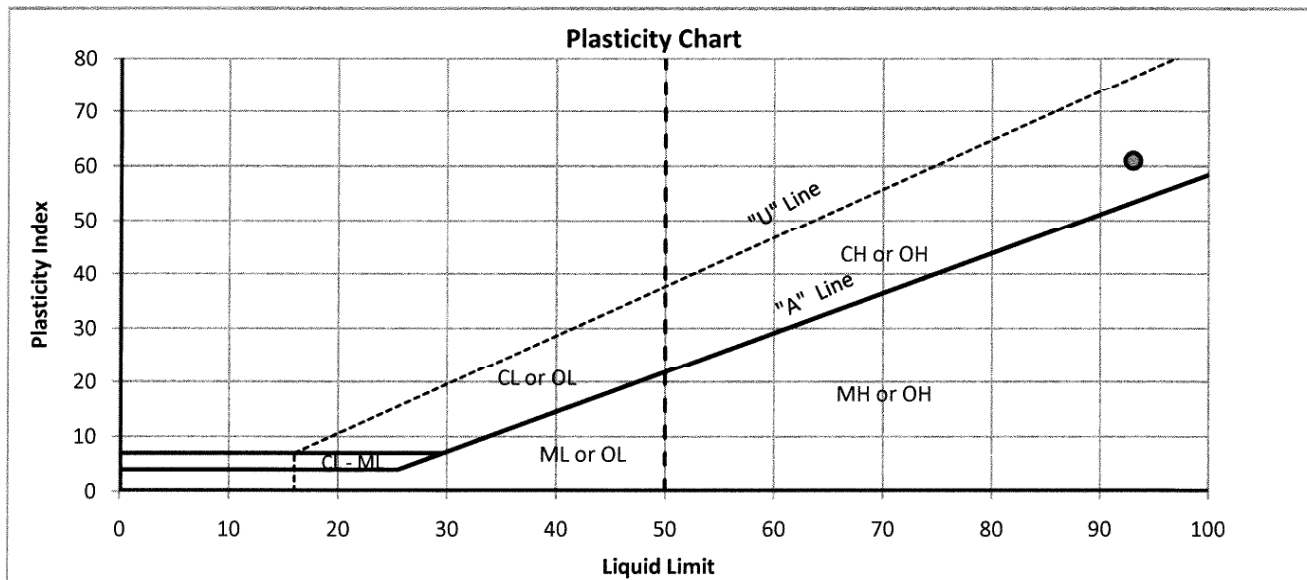
ATTERBERG LIQUID LIMIT AND PLASTIC LIMIT DETERMINATION

Natural Moisture Content: 38%
Estimated % retained on 0.425 mm sieve: 0%

Liquid Limit: 93
Plastic Limit: 32
Plasticity Index: 61
USCS Classification: CH Inorganic clays of high plasticity

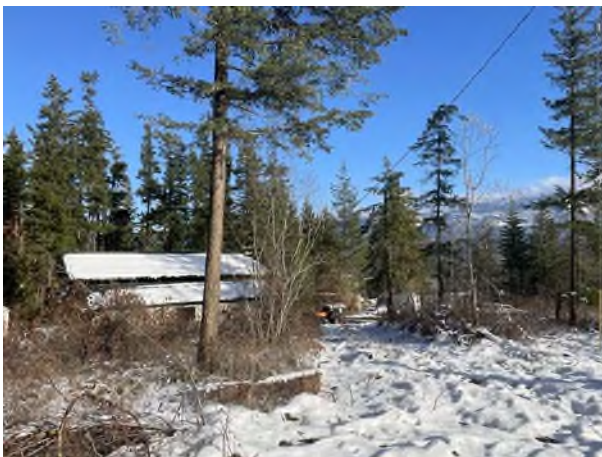
The area adjacent to the structure is mostly cleared with only a few mature trees nearby.

- Vegetation within 1.5m of the residence is to be removed. Do not plant or cultivate vegetation within 1.5m of any new buildings.
- Ensure woodpiles and other combustible material is stored >10m from residence.
- Mature coniferous trees within 30m of residence to be pruned such that branches are >3m from the ground.
- Immature coniferous trees within 10m of residence to be removed.
- Immature coniferous trees 10m-30m from residence should be spaced 3 crown widths and pruned to the greater of 3m or 40% of their live crown.
- Juniper, if present within 10m of residence to be removed.

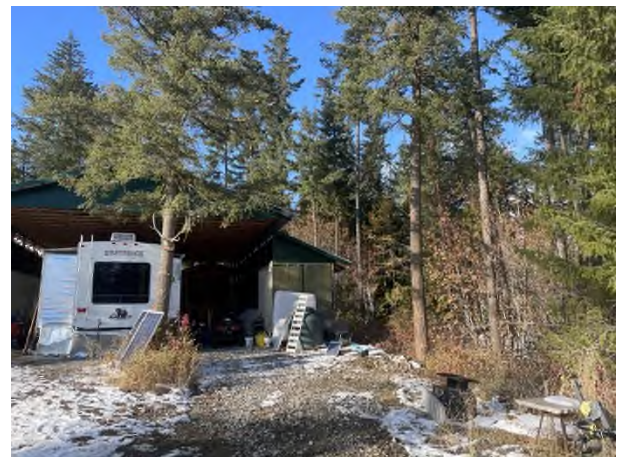
Conifers close to the residence.

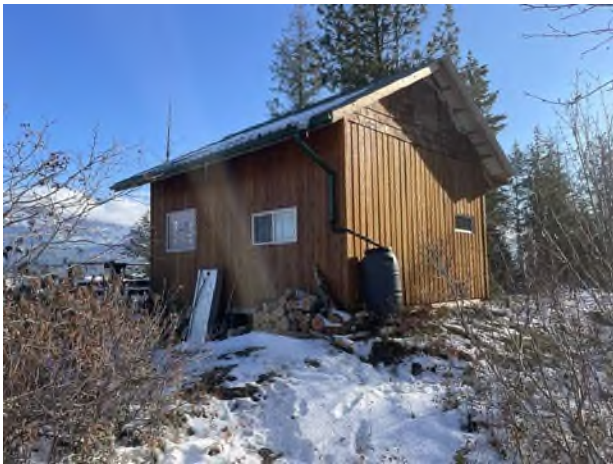
Firewood stacked against the building.

- Do not stack wood against the building. Ensure woodpiles and other combustible material is stored >10m from residence.
- Prune the ponderosa pine tree such that there are no branches below 3m. Mature coniferous trees within 30m of the building to be pruned such that branches are >3m from the ground.
- Vegetation within 1.5m of the residence is to be removed. Do not plant or cultivate vegetation within 1.5m of any new buildings.
- Immature coniferous trees within 10m of residence to be removed.
- Immature coniferous trees 10m-30m from residence should be spaced 3 crown widths and pruned to the greater of 3m or 40% of their live crown.
- Juniper, if present within 10m of residence to be removed.

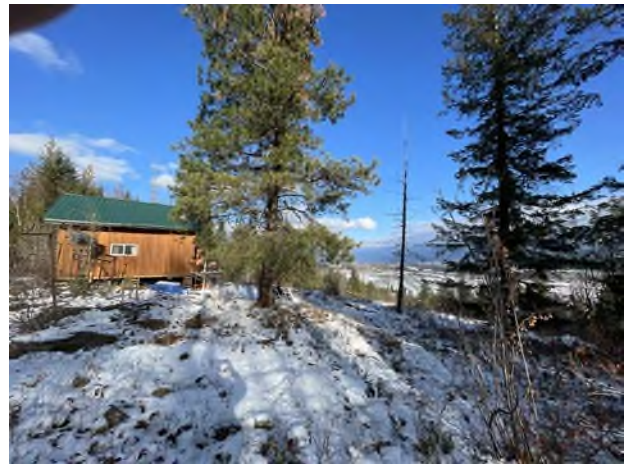
Ponderosa Pine tree to be pruned.

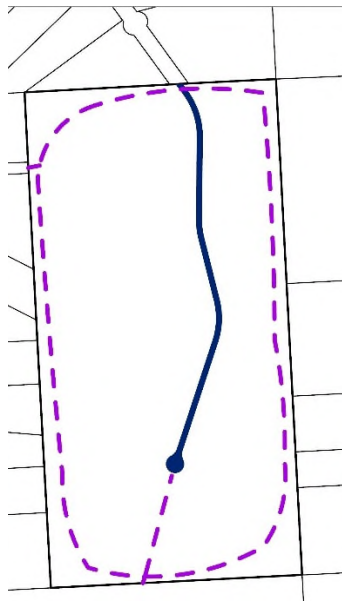
Secondary emergency circulation route displayed as purple dashed line.

- Maintain the proposed secondary emergency circulation route so that this route is accessible for potential firefighting activities. Future sub-divided properties must not block this route. Any fences that intercept this route must be gated so that emergency vehicles can pass through.
- The combination of the secondary emergency circulation route and the main access road will provide access/egress and act as fireguards.
- Minimize vegetation within 5m of the access road and secondary emergency circulation route.
- Trees within 5m of the access route secondary emergency circulation route must be pruned to 3m. Vegetation underneath the drip line of these trees that could potentially act as a ladder fuel must be cleared. The intent is to reduce the amount of combustible material immediately adjacent to the trail so that it is a more effective fire guard.

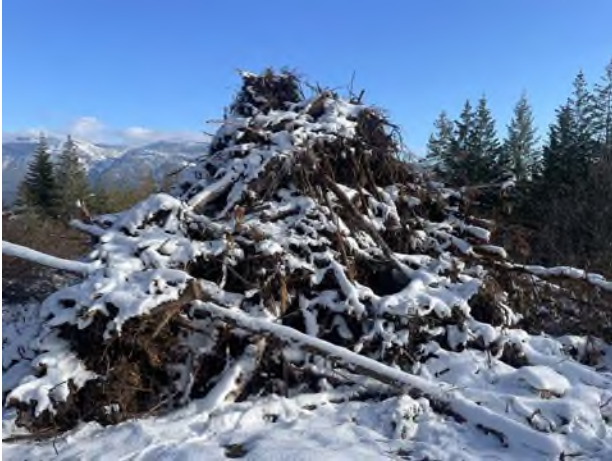
Debris pile to be disposed

- Dispose of debris pile as soon as practicable.

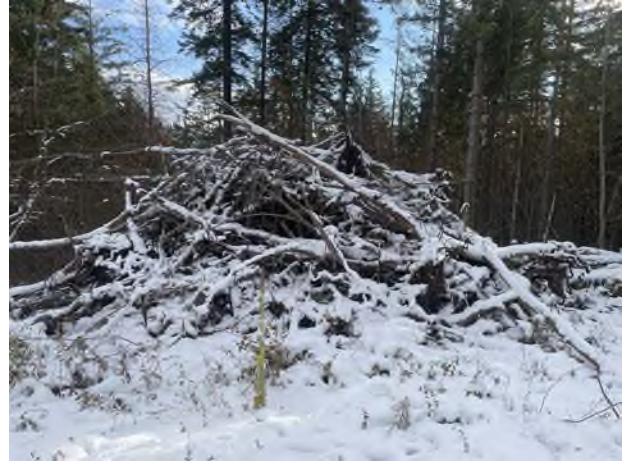
Debris pile to be disposed

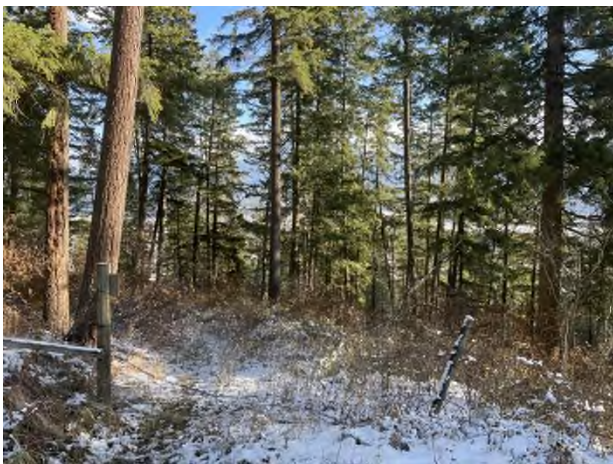
Typical forest.

- When clearing trees for subdivision and building sites, ensure sufficient combustible material is cleared such that future residential infrastructure will be consistent with current FireSmart recommendations.
- Consider additional tree removal throughout the property targeting an average of at least 1 crown width spacing between the crowns of the trees that are retained.
- Pile and burn deadfall material.
- Limb blowdown such that it will lay flat on the ground.
- Prune retained conifers up to 3m.
- Reduce conifer density of the understory and overstory of the forest such that if a fire approaches it will drop from a crown fire to a ground fire.

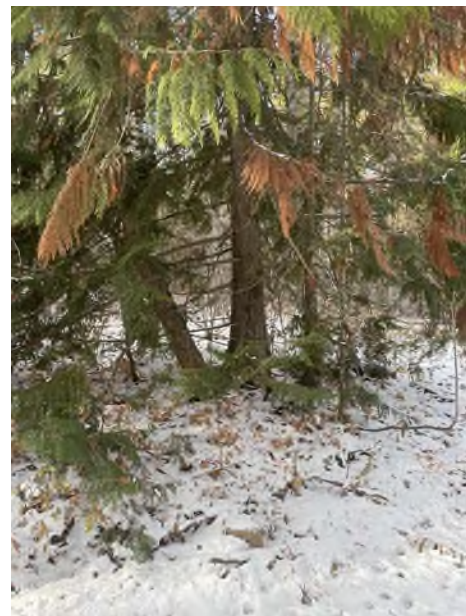
Cedar with branches to the ground.
