Veg Pro Flood Management Plan Coldstream Creek in Coldstream, BC

WWAL Project 18-067-01

Re: Flood Management Plan for Veg Pro International in Coldstream, BC

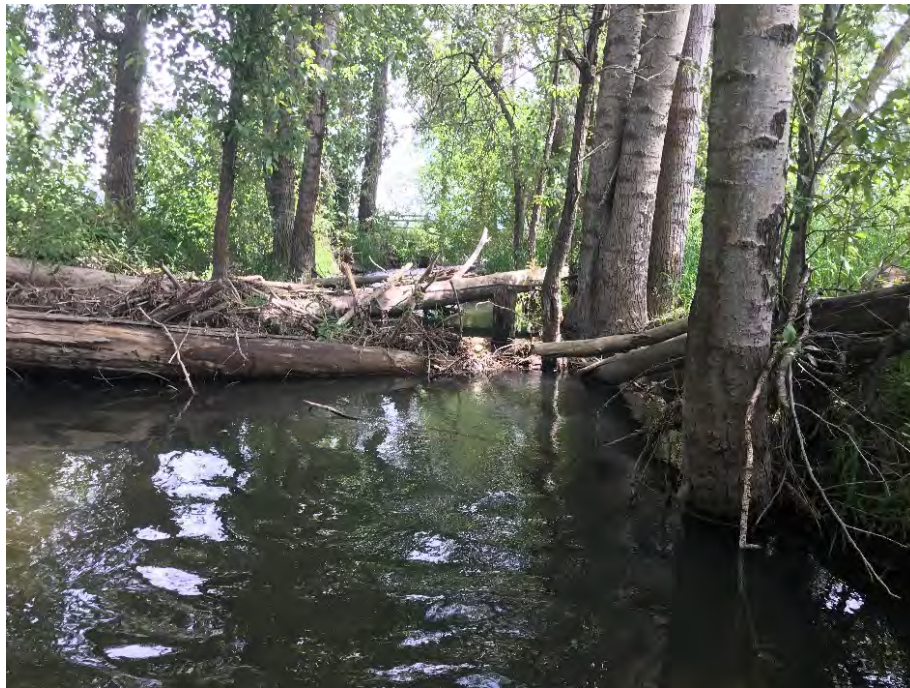
Photograph 4. Log jam in Coldstream Creek inhibiting flow (July 9, 2018)

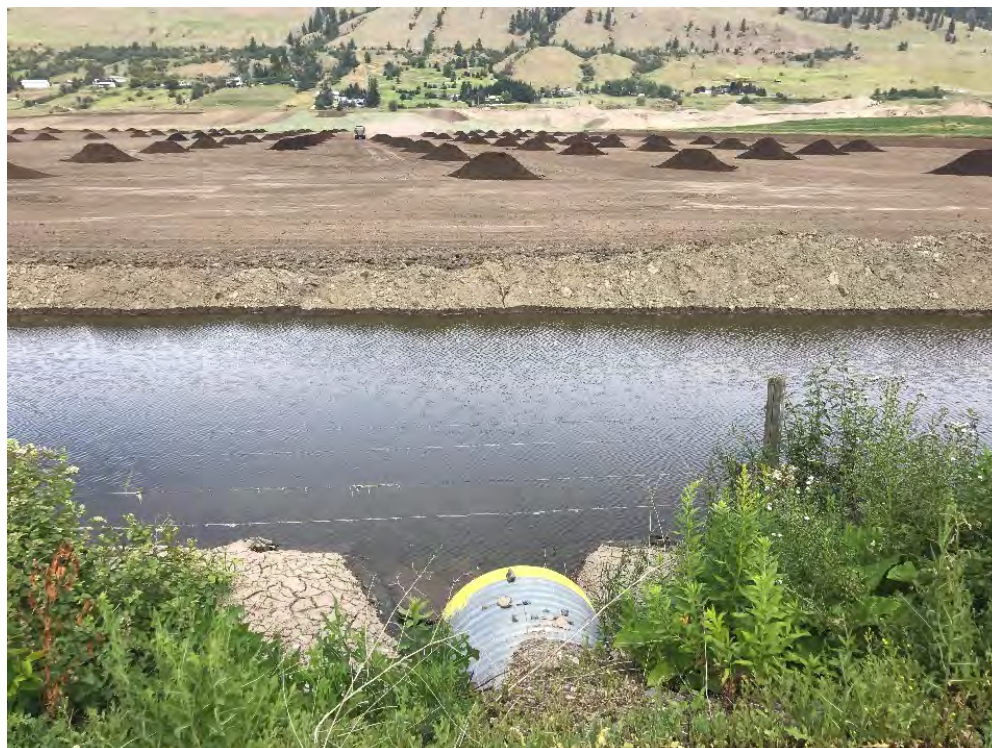
Photograph 6. Man-made channel fed by the culvert under the rail line (July 9, 2018)

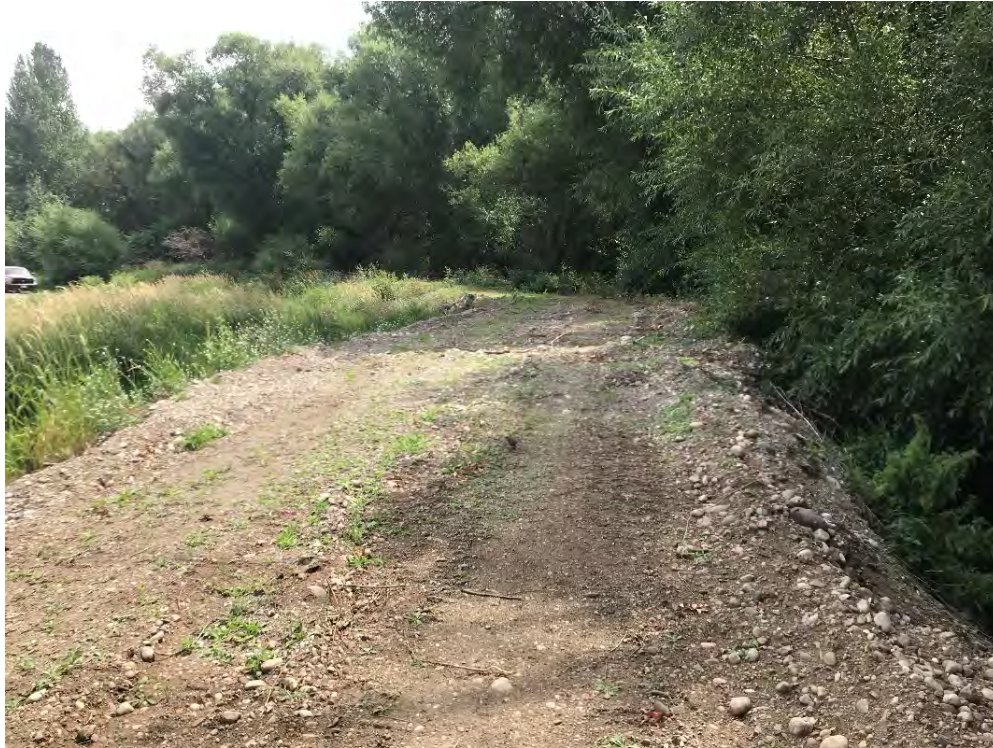
Photograph 9. Existing berm (July 9, 2018)

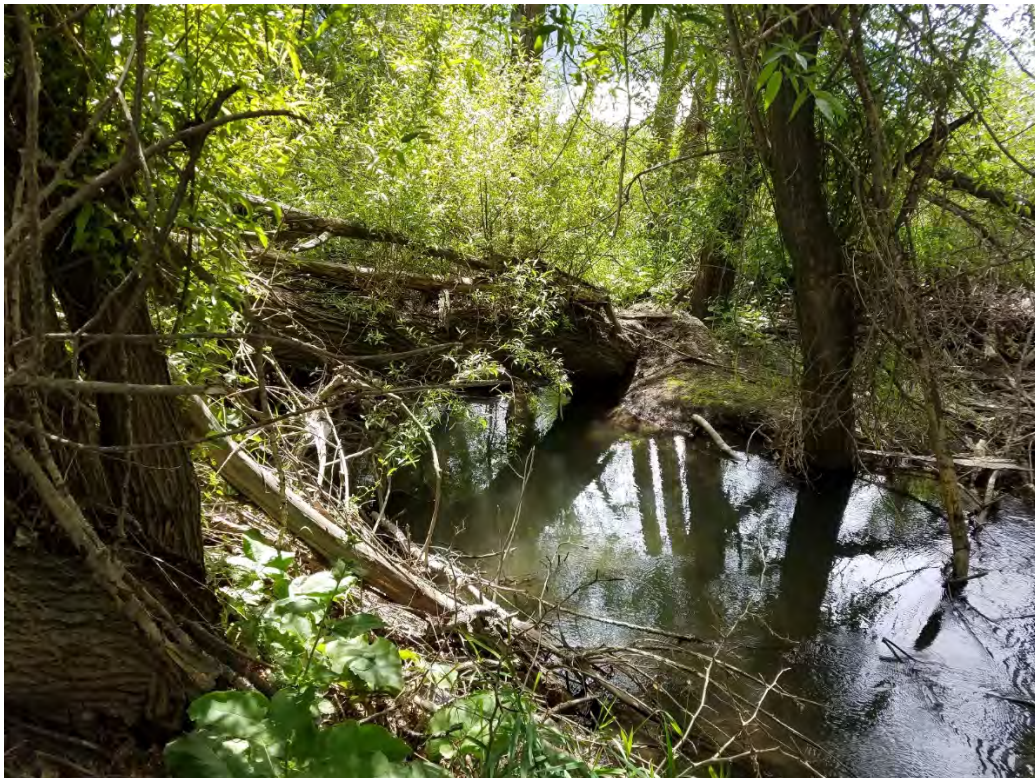
Photograph 10. Log jam in Coldstream Creek inhibiting flow (July 9, 2018)

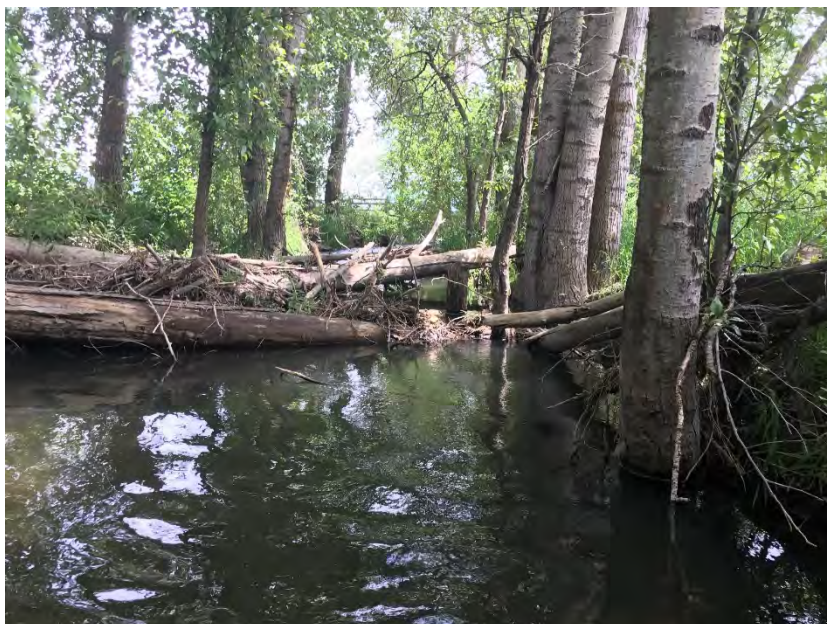
Photograph 12. Log jam in Coldstream Creek inhibiting flow (July 9, 2018)

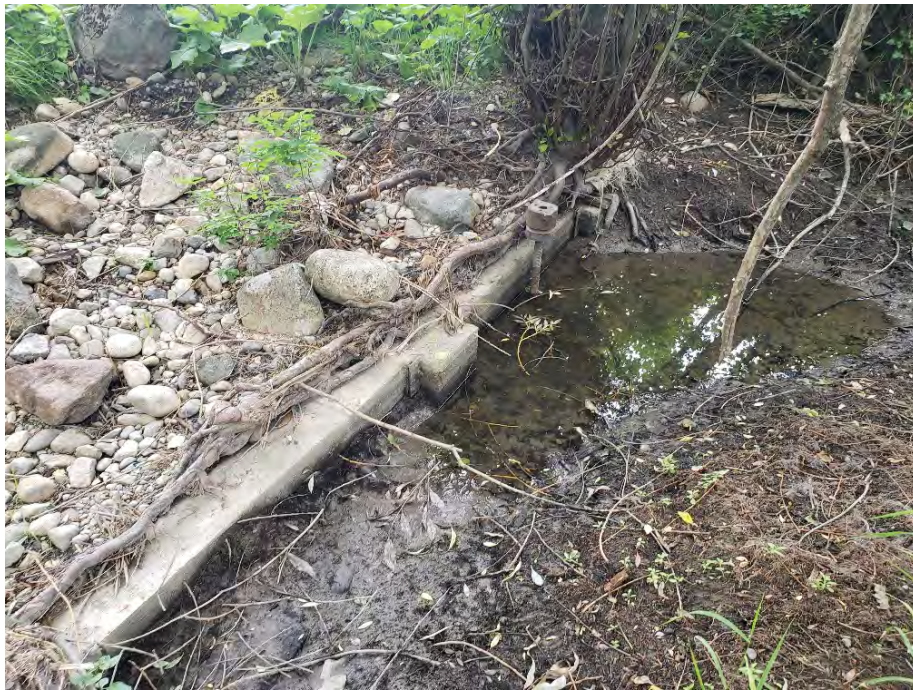
Photograph 15. Concrete infrastructure to be removed from Coldstream Creek as it has filled with sediment and is blocking creek flow (July 9, 2015)

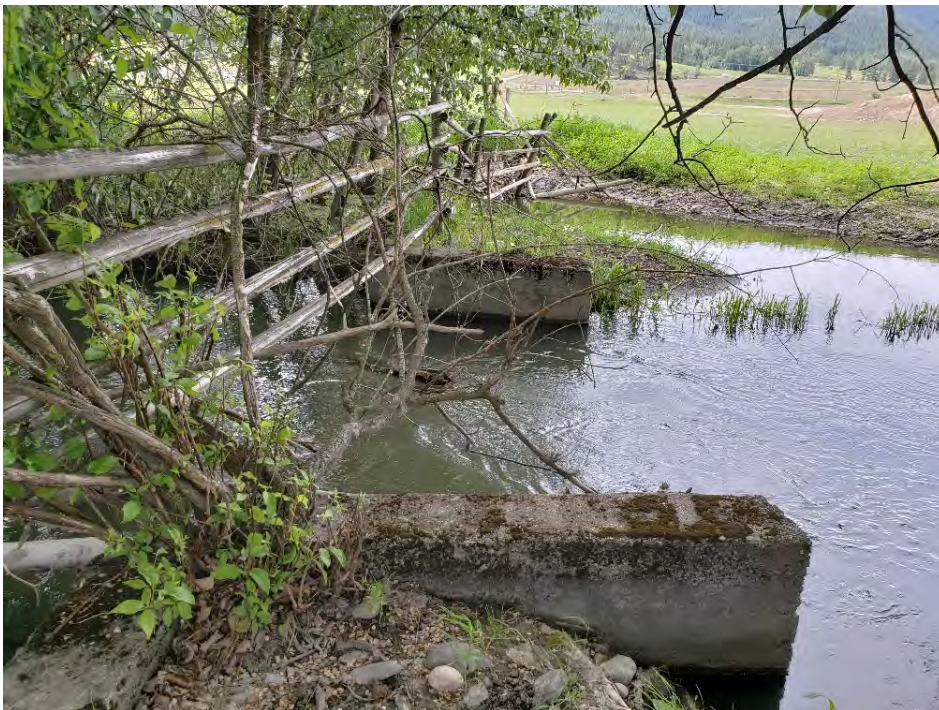
Photograph 16. Old concrete irrigation infrastructure to be removed from Coldstream Creek as it is inhibiting creek flow (July 9, 2015)

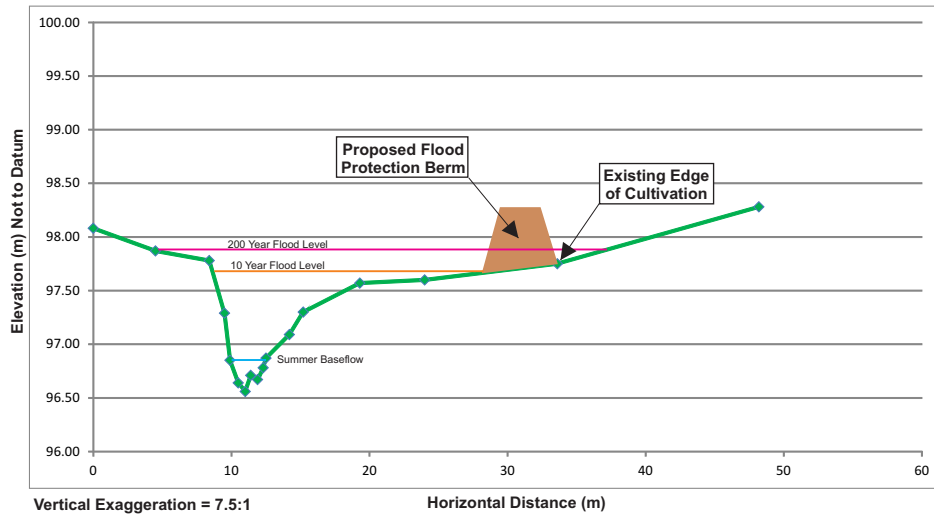
XSection #1

Proposed Berm on Right (north) Bank (Section A - See Figure 1 and 2C)
 Approximate Height of Berm = 0.6m
 Freeboard = 0.3m
 Approximate Elevation of Berm = 1.2m (above baseflow water level).
 Approximate Offset from Top of Bank = 14m
 Preserved Floodplain Width = 25m

A similar berm may be considered on the Left (South) bank to match the elevation of the Right bank (equivalent freeboard). (Section B - See Figure 1)
 No floodplain encroachment.

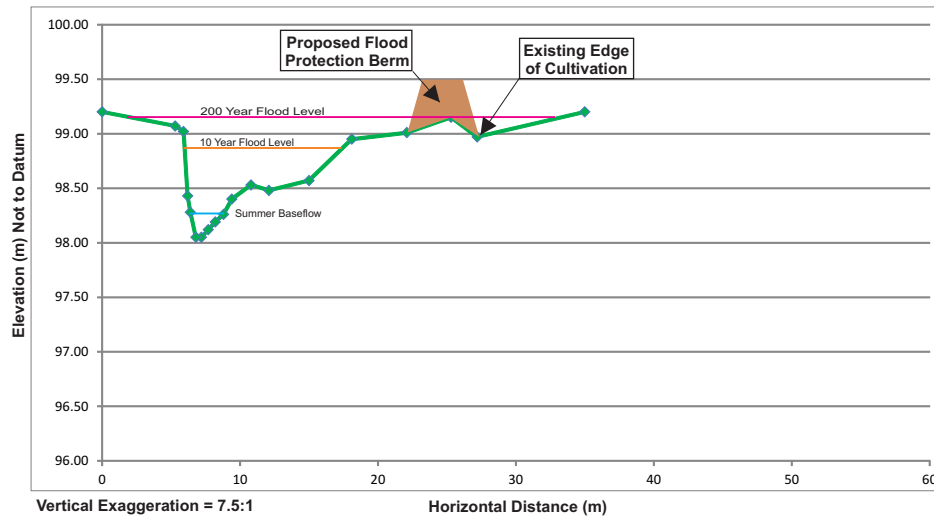
XSection #2

Proposed Berm on Right (north) Bank (Section A - See Figure 1 and 2C)
 Approximate Height of Berm = 0.5m
 Freeboard = 0.3m
 Approximate Elevation of Berm = 1.2m (above baseflow water level).
 Approximate Offset from Top of Bank = 4m
 Preserved Floodplain Width = 18m

A similar berm may be considered on the Left (South) bank to match the elevation of the Right bank (equivalent freeboard). (Section B - See Figure 1)
 No floodplain encroachment.

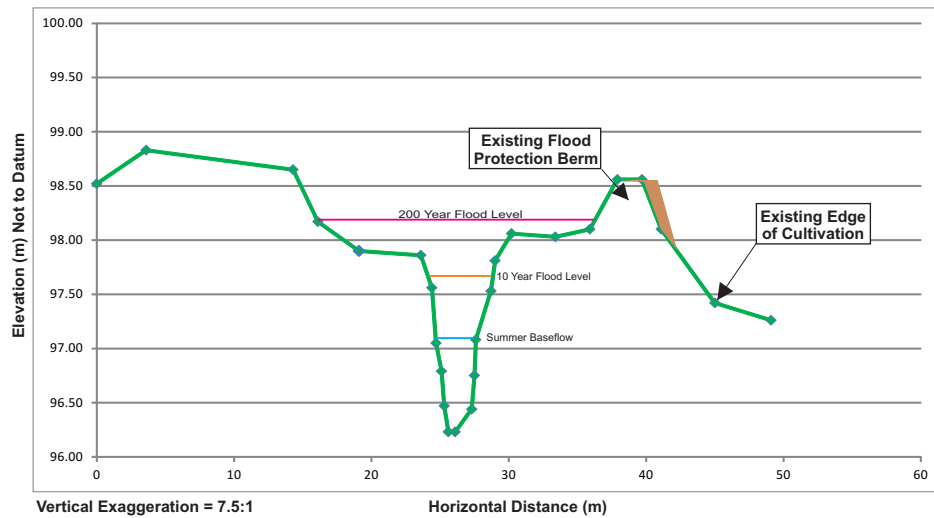
XSection #3

Existing Berm on Right (north) Bank (Section C - See Figure 1)
 Improve existing berm as required.
 Approximate Height of Berm = 0.5m
 Freeboard = 0.35m
 Approximate Elevation of Berm = 1.5m (above baseflow water level).
 Approximate Offset from Top of Bank = 6m
 Preserved Floodplain Width = 20m

No berm required on the Left (South) bank.

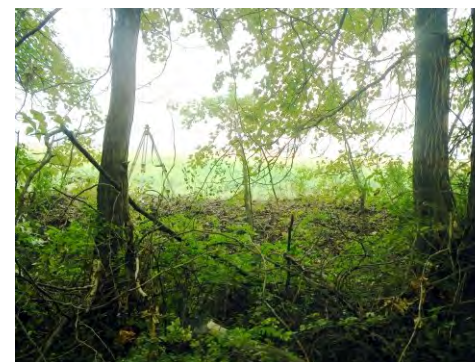
Looking across XS#3 toward the right (north) bank with the existing berm.

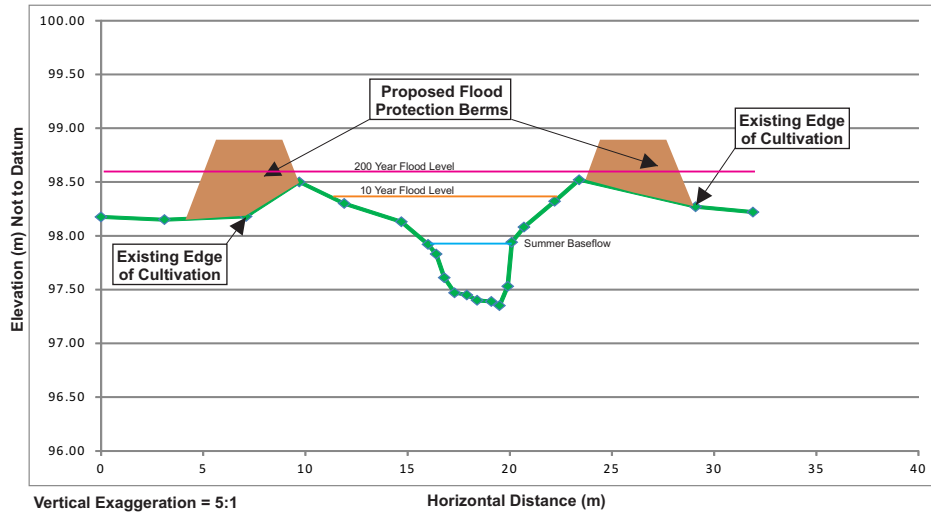
XSection #4

Proposed Berm on Right (north) Bank (Section C - See Figure 1)
 Improve existing berm in some areas.
 Approximate Height of Berm = 0.6m
 Freeboard = 0.3m
 Approximate Elevation of Berm = 1.0m (above baseflow water level).
 Approximate Offset from Top of Bank = 1m
 Preserved Floodplain Width = 14m
 Some Loss of Flood Relief

Proposed Berm on Left (south) Bank (Section D - See Figure 1)
 Some existing berm, connect into existing berm at upstream end.
 Approximate Height of Berm = 0.7m
 Freeboard = 0.3m
 Approximate Elevation of Berm = 1.0m (above baseflow water level).
 Approximate Offset from Top of Bank = 0m
 Preserved Floodplain Width = 14m
 Some Loss of Flood Relief

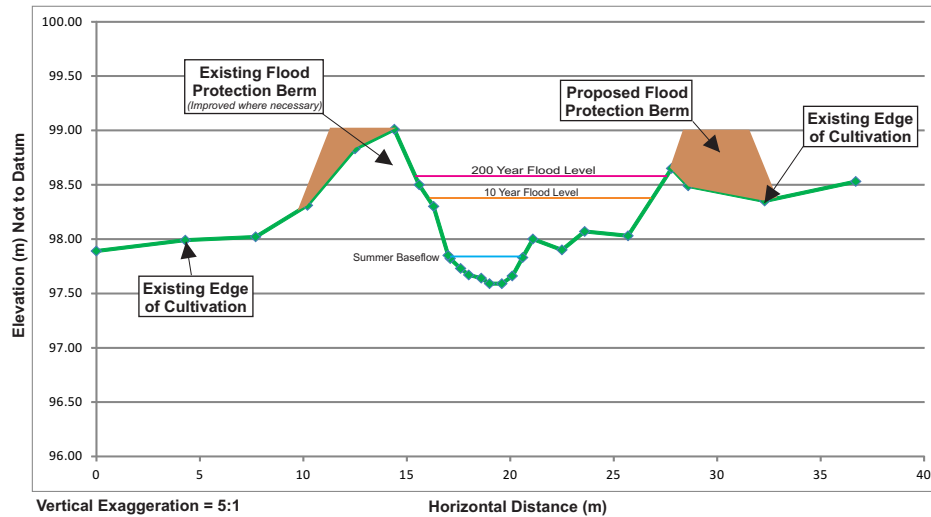
XSection #5

Proposed Berm on Right (north) Bank (Section C - See Figure 1)
 Approximate Height of Berm = 0.6m
 Freeboard = 0.4m
 Approximate Elevation of Berm = 1.2m (above baseflow water level).
 Approximate Offset from Top of Bank = 7m
 Preserved Floodplain Width = 13m

Existing berm on the Left (South) bank may be improved/augmented where necessary to ensure an equivalent height and proper function.

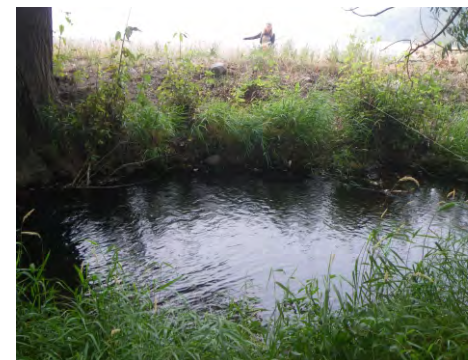
Looking across XS#5 toward the left (south) bank and the existing berm.

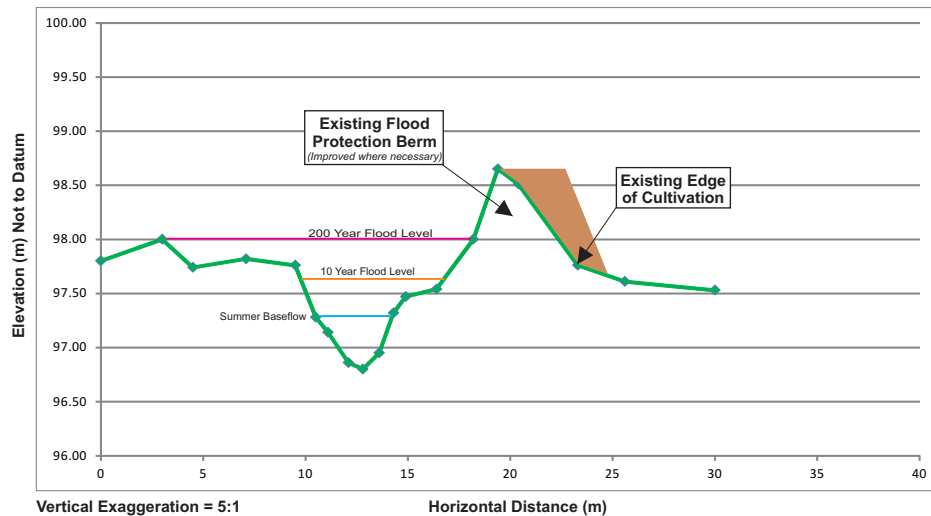
XSection #6

Existing Berm on Right (north) Bank (Section E - See Figure 1)
 Approximate Height of Berm = 1.0m
 Freeboard = 0.6m
 Approximate Elevation of Berm = 1.35m (above baseflow water level).
 Approximate Offset from Top of Bank = 4.5m
 Preserved Floodplain Width = 15m

No berm required on the Left (South) bank (flood limited by railway grade).

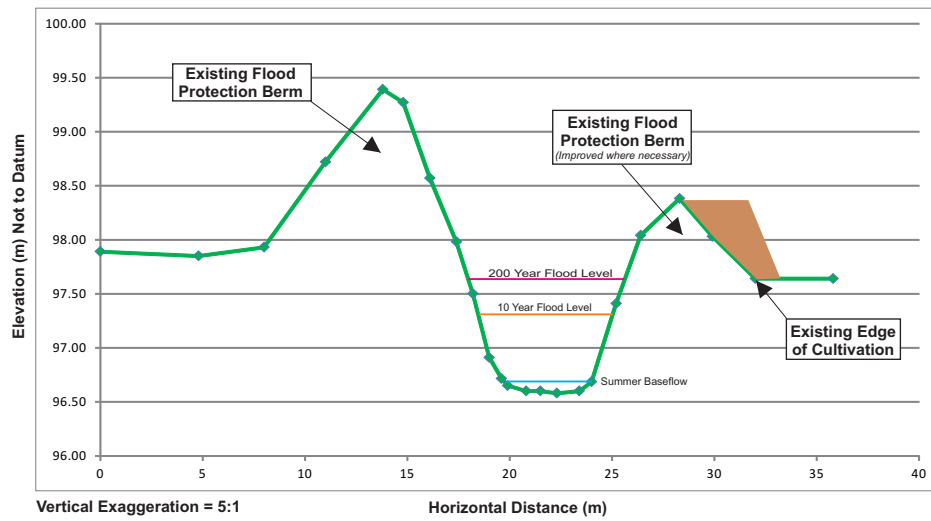
XSection #7

Existing Berm on Right (north) Bank (Section E - See Figure 1)
 Existing berm improve where necessary
 Approximate Height of Berm = 0.75m
 Freeboard = 0.7m
 Approximate Elevation of Berm = 1.7m (above baseflow water level).
 Approximate Offset from Top of Bank = 3m
 Preserved Floodplain Width = 10m

Existing Berm on Left (south) Bank
 Approximate Height of Berm = 1.5m
 Freeboard = 1.7m
 Approximate Elevation of Berm = 2.7m (above baseflow water level).
 Approximate Offset from Top of Bank = 3m
 Preserved Floodplain Width = 10m

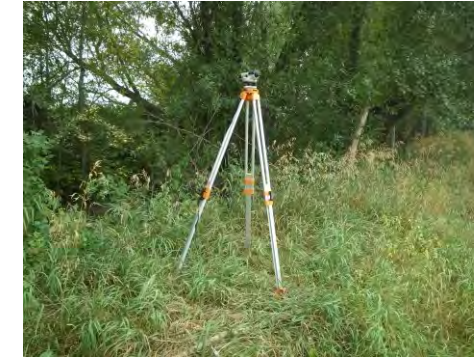
Survey instrument on top of existing berm at XS#7.
