Mabel Lake Water: Preliminary Source Water Assessment

**Prepared for: Regional District of North Okanagan
FINALIZED – Dec 21, 2021**

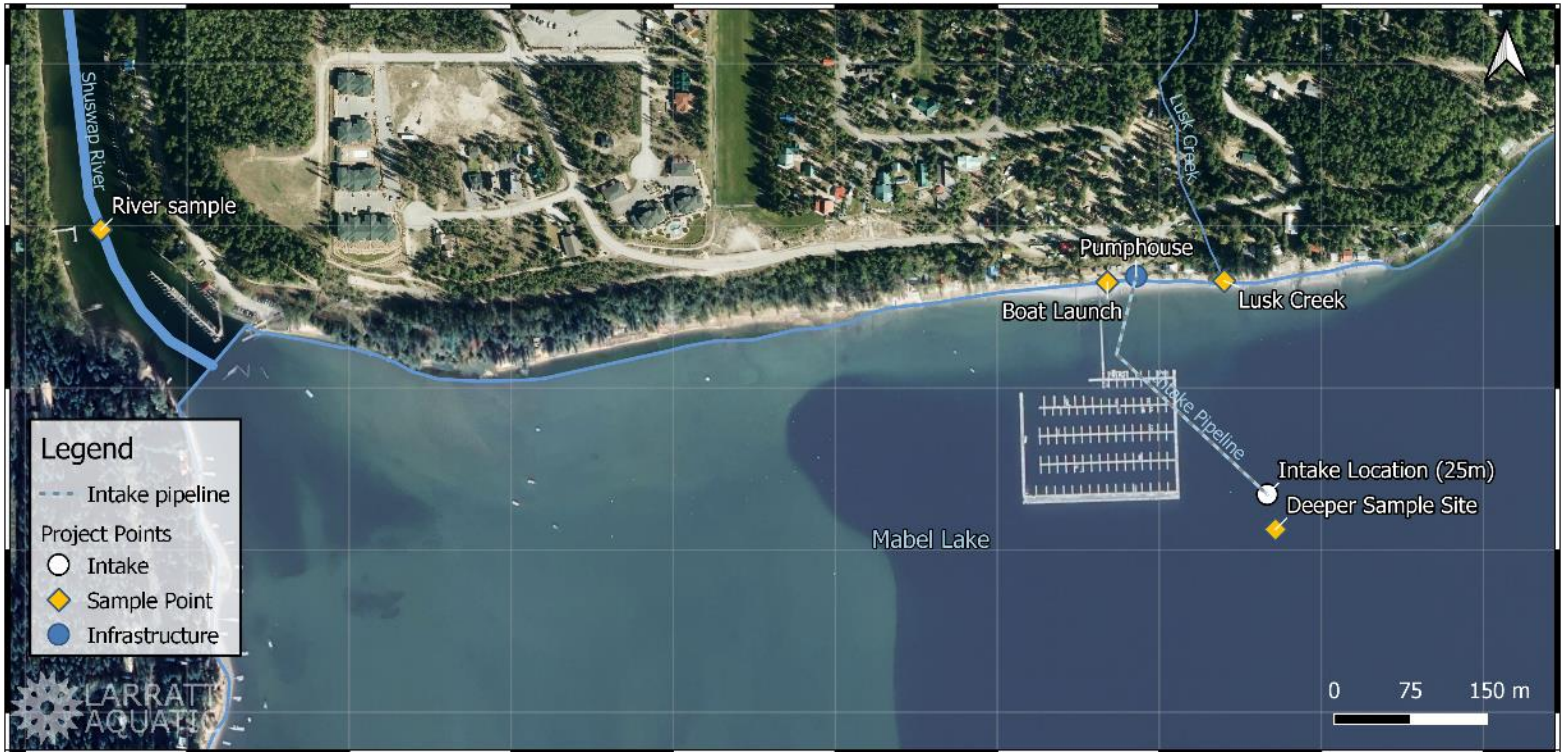
Figure 1: Map of Mabel Lake sampling program

Sampling focused on four areas in Mabel Lake: Lusk Creek, the current intake, near the boat launch, and at the river outlet west of the boat launch (Figure 1). In each area water chemistry

was collected and additional algae collection and drogue runs were performed near the current intake and boat launch (Figure 1).

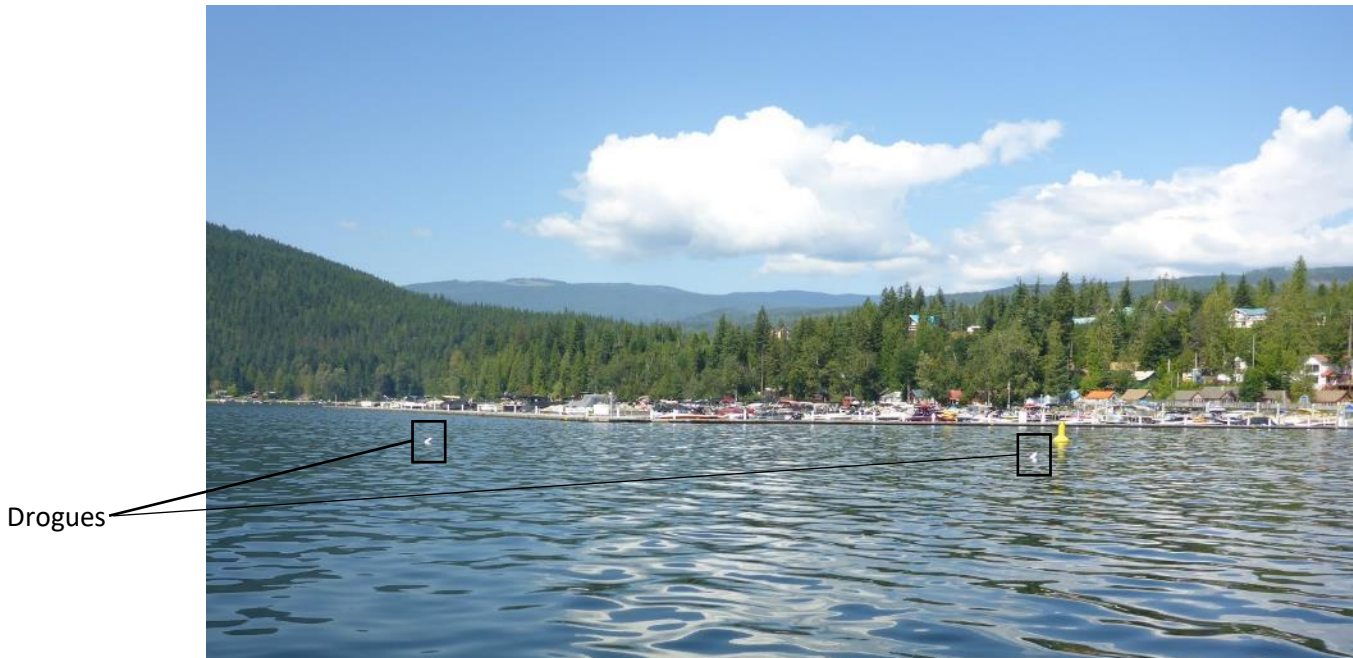
Figure 2: Photograph of drogue floats near current intake

Drogues are weighted baskets connected to a float via a rope of specific length such that they can be used to track water currents at a given depth. During this study, drogues were deployed at depths of 5 m, 10 m, 20 m, and 30 m around the intake location. The drogues results are used to define the proposed intake protection zone.

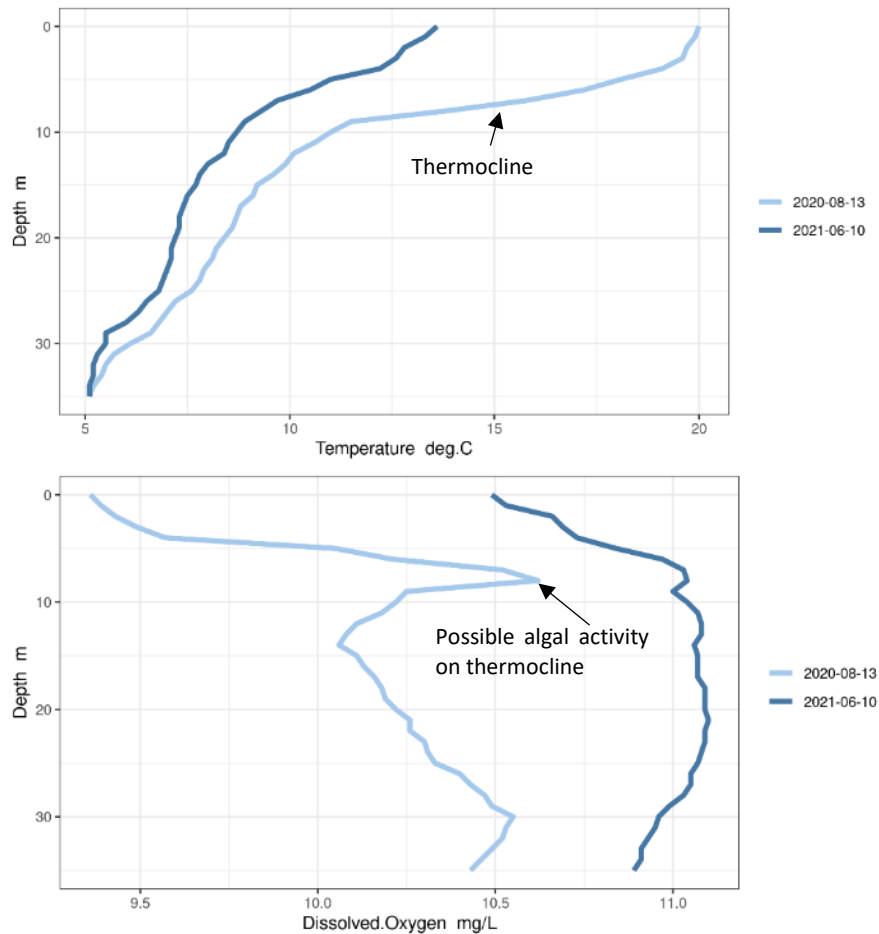
Figure 5: Temperature and dissolved oxygen profiles from Mabel Lake near the intake during sample trips

Water temperature in Mabel Lake varied from 20 °C at the surface to 5.1 °C at 35 m on Aug 13, 2020 and 13.6 °C at the surface to 5.1 °C at 35 m on Jun 10, 2021 (Figure 5). Dissolved oxygen was high throughout the water column on both dates but there was evidence of significant algal activity at the thermocline on Aug 13, 2020 (Figure 5).

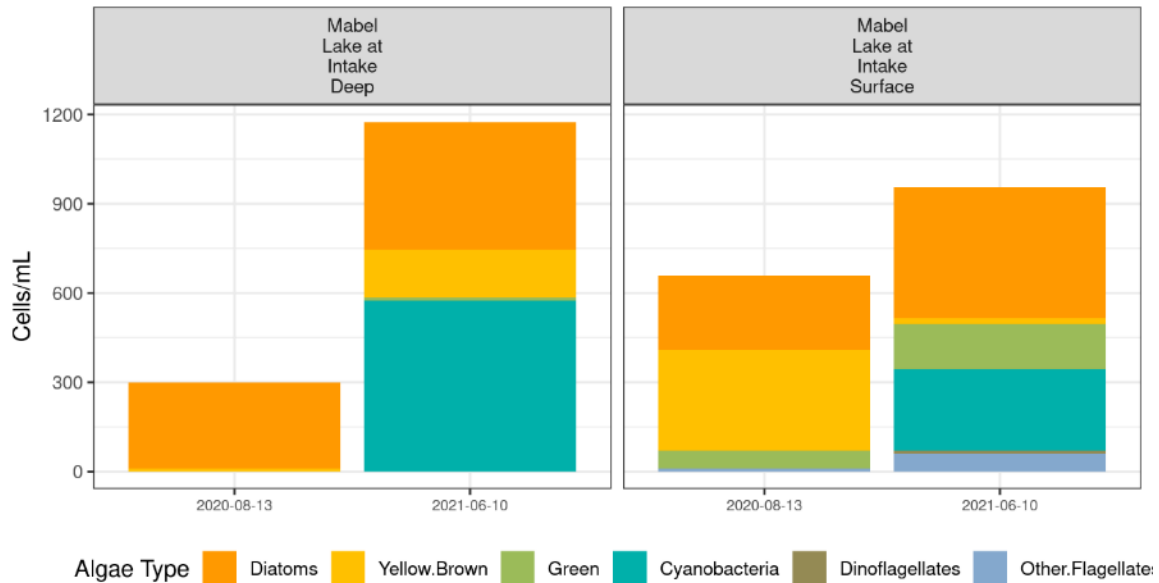
Figure 6: Algae densities in Mabel Lake at the intake

Algae samples were collected near the intake location from the surface and the intake depth (26 m) on Aug 13, 2020 and Jun 10, 2021. Densities during both trips were low, an expected result given the high water-clarity on both trips (Figure 6). A mixture of diatoms, flagellates, and cyanobacteria were noted but densities were too low to adversely affect water quality (Figure 6).

Water clarity was high on both trips but was greater during the August 2020 trip (9.8 m) than the June 2021 trip (7.4 m) because the August trip occurred during the clear phase of the lake which is after the effects of freshet have passed and spring algal activity has diminished (Figure 6). The June trip occurred during freshet.
